**PHASE 1 OF A HISTORIC STRUCTURE REPORT
HAPPY RETREAT
CHARLES TOWN, WEST VIRGINIA**

MARCH 2017

The purpose of this Phase 1 of a historic structure report was to provide a general overview of Happy Retreat’s history, trace the development of the house and refine the chronology of the building’s construction, and assess the level of historic fabric that remains from before the 1954 renovation. In addition, a conditions assessment was performed on the smokehouse/kitchen/privy outbuilding, which included a structural investigation undertaken by a consulting engineer. The rest of the 1842 house was only documented and studied on a cursory level, as the FOHR expressed the desire to focus on the first floor of the west wing, considered to be the oldest portion of the house and the one associated with the original owner, Charles Washington. A prioritized list of recommendations has been developed with reference to structural concerns, preservation issues, future research, and interpretive opportunities.

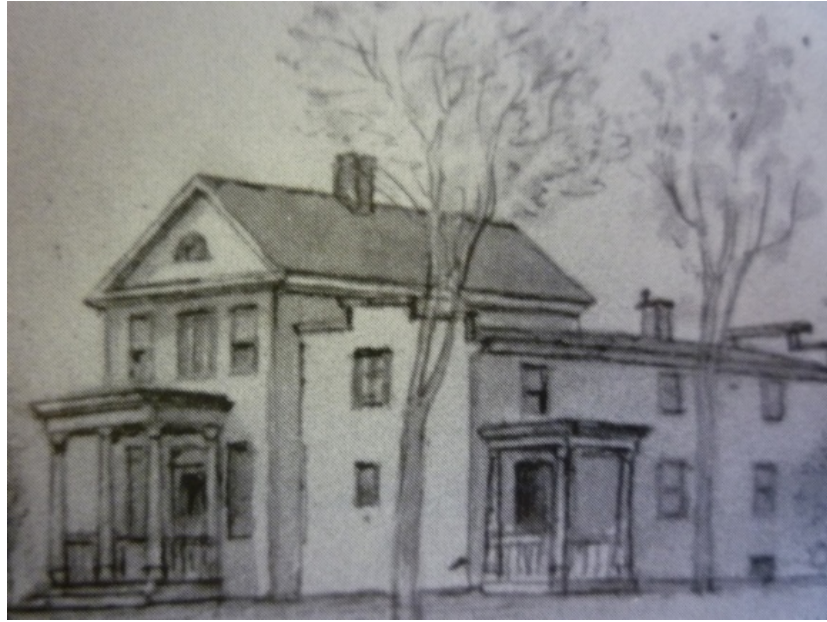
Figure 3. From the *James E. Taylor Sketchbook*, Happy Retreat in 1864 (Western Reserve Historical Society, Cleveland, Ohio).

Town area but admitted that he didn't get a close view of it. Perhaps that explains why only one wing is depicted.

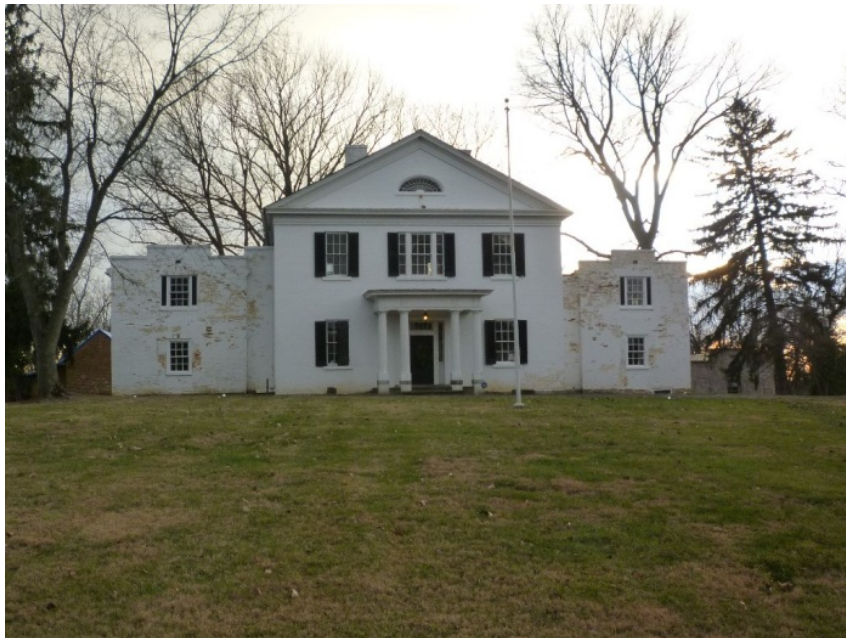
Figure 1. North view of house (2016).

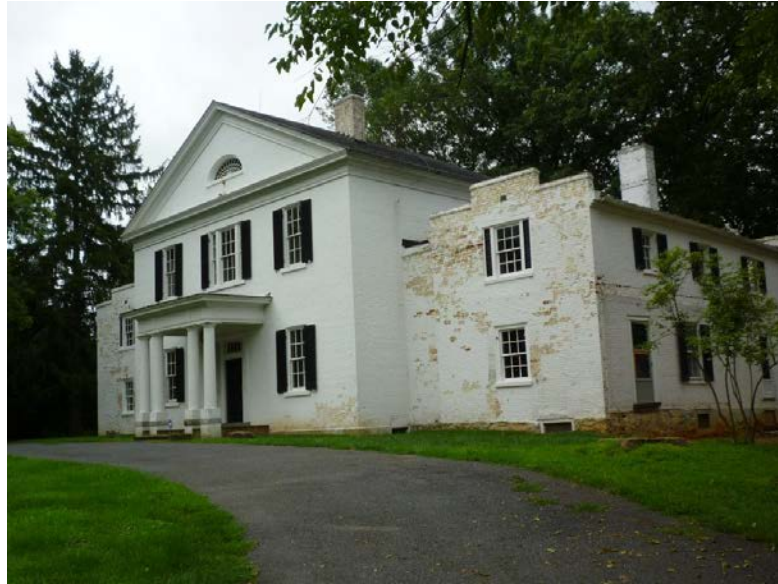
Figure 3. Northwest view (2016).

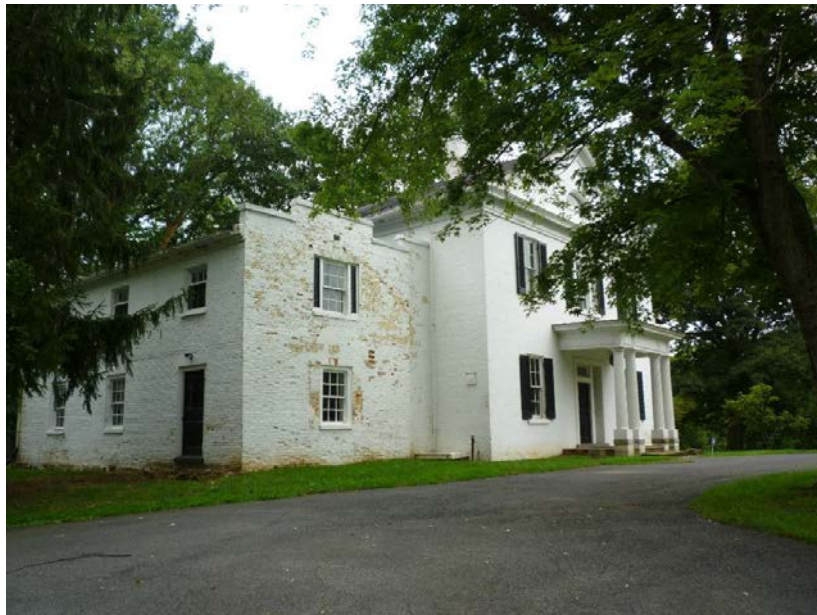
Figure 4. Northeast view (2016).

The rear of the main block is composed of four symmetrically-placed window bays on the first and second floors and a similar but shorter window centered in the attic gable. The shutters have been removed. A metal bulkhead covers a basement entry near the southeast corner.

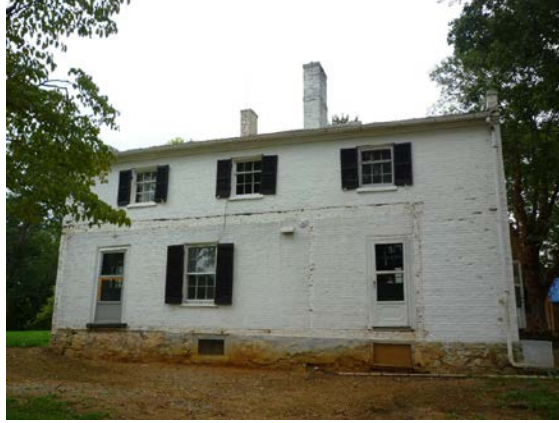
The first floor of the west wing was constructed in two phases, as is clearly indicated by a visible vertical seam positioned midway along both the east and west sides. These units were originally one story in height, as is evidenced by the distinctive difference in the brick bonding on the second floor. They would have had gabled roofs with the fronts and rears facing east and west. The earliest section, ca. 1780, is the north end (Room 105), which is laid in Flemish-bond brick on the north and east elevations, suggesting these were the principal facades. The less formal 3:1 common bond is used on the west and south sides. The north end contains a central six-over-six-sash window; a six-light fixed basement window is located below and slightly closer to the northwest corner. The west elevation has both a six-over-six-sash window with louvered wooden shutters and a door that once lead out to a frame porch; the porch was later expanded into a patio that ran the full length of the wall, and which was removed in 2016. Beneath the window is a fixed six-light basement window. Two S-shaped iron tie rod anchors, probably inserted in the 1954 renovation to stabilize the walls, are found on the northwest corner at the top of the first floor. The east elevation contains a doorway that is now enclosed by the hyphen, and one six-over-six window with louvered shutters that looks out onto the narrow brick-floored space between the hyphen and the main block. Just beneath it at the basement level is a row of soldier bricks that correlates with an earlier entry to the basement. The window and door openings all have brick jack arches.

Figure 6. West view of west wing (2016), after the patio had been removed.

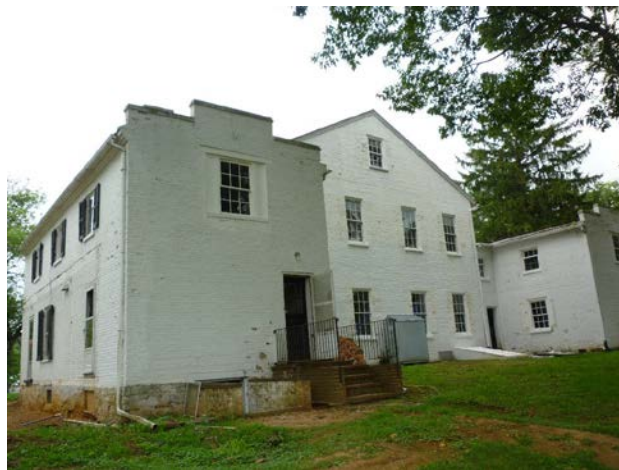
Figure 7. Southwest view of west wing (2016).

The rear (south) portion of the west wing is the same width as the original section and was probably added ca. 1785. The east wall is laid in Flemish bond, matching the pattern on the east wall of the original section fairly closely. The other walls are laid in 3:1 common bond. The east wall contains a centered six-over-six-sash, double-hung wood window. Beneath it is a six-light fixed basement window with a brick window well. A door in the eastern-most bay of the south side is the only opening on that first-floor elevation and is fronted by a brick stoop and steps with wrought iron handrails. To the left of the doorway are a pair of brick parapet walls that frame the brick stairs leading down to a double-leaf wooden basement entry door that is topped by a wooden lintel. The west side also contains a door with a brick jack arch; a rectangular basement window that has been enclosed with plywood is located below the doorway. The second floors of both of these portions of the west wing are laid in 5:1 common bond, generally matching the brickwork in the south, east, and west walls of the main block. Three three-over-six-sash wood casement windows with jack arches and louvered shutters are symmetrically spaced along the west side, with another (without shutters) along the east side. Centered on the front and rear gable ends of the second floor are six-over-six-sash double-hung wood windows. The window on the north is flanked by narrow wooden louvers and the one on the south by narrow panels; both are topped by wooden lintels. Above the north

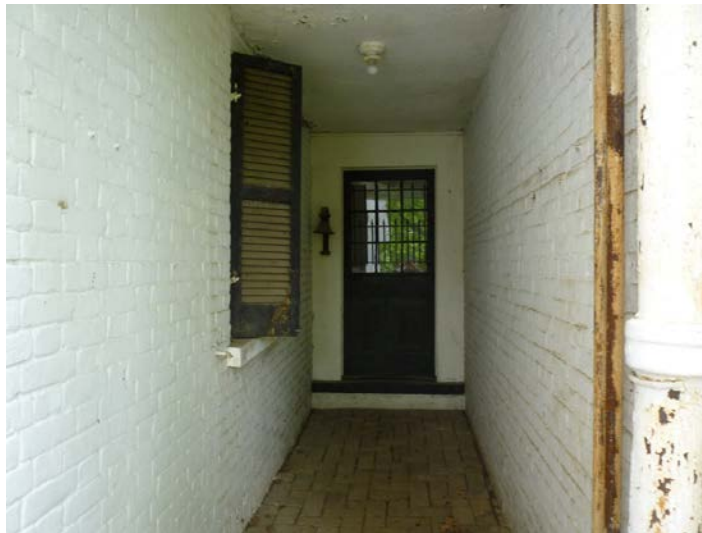
While the brickwork of the short hyphen connecting the west wing to the main block does not completely match the brick pattern in the 1842 section, it was probably constructed at the same time or shortly thereafter. The connector rests on a low stone foundation and sits back slightly from the north face of the west wing; there are no openings on the north side, but a doorway is centered on the south wall. The lower half of the wooden door is composed of six panels; the upper portion is six glass panes fixed in a wood frame, protected by metal bars. The hyphen has a frame extension on the second floor of the south side that houses a bathroom, and which covers a brick-floored passage that leads to the entry. A one-over-one-sash window is centered on the south wall of the extension.

Figure 8. View of rear of west hyphen (2016).

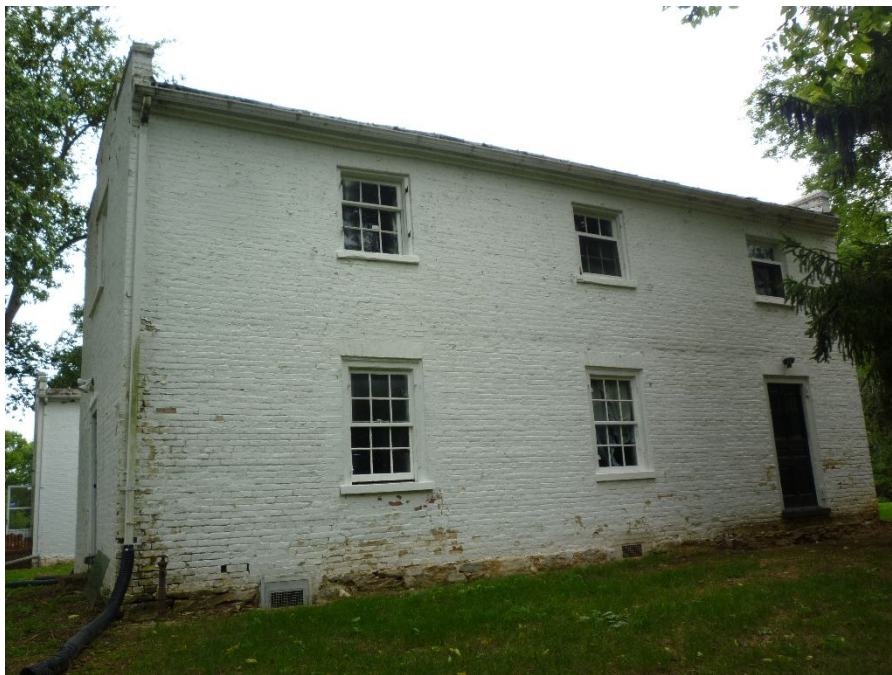
The east wing is connected to the main block by a two-story hyphen that runs the full length of the wall. . According to the exterior brick pattern, the entire first floor was constructed at one time, probably when the rear section for the west wing was built. The building had a central chimney, which was removed in 1954. The north end and the west side of the first floor are laid in Flemish-bond brick and face the “front” (east side) of the west wing. The other first-floor elevations are laid in 3:1 common bond; the second floor in 5:1 bond. The window and door openings have brick jack arches. The north façade has a centered six-over-six-sash window; the three-bay east elevation has a doorway on the northern-most end and two six-over-six-sash windows centered on the remaining part of

the wall. The door once led to a masonry patio that was removed recently. A doorway with a wooden lintel is centered on the south wall; the west side has a six-over-six-sash window. As on the west, this wing is covered by a gabled roof with stepped brick parapet ends and a corbelled brick cornice. The six-over-six-sash gable-end windows, and the three-over-six-casement windows on the east wall are almost identical to those on the west wing. A portion of the standing-seam metal roof has been covered with a rubberized membrane. A bronze plaque is set in the north gable end, which is dedicated in the memory of Charles Washington, and which is similar in style and shape to the one for Charles Conklyn in the west wing. The hyphen between the east wing and the main block is similar to the one connecting the west wing. It was in 1954 that the hyphen was extended to the south on both levels to accommodate an extended hallway with a new staircase.

Figure 9. East view of east wing (2016).

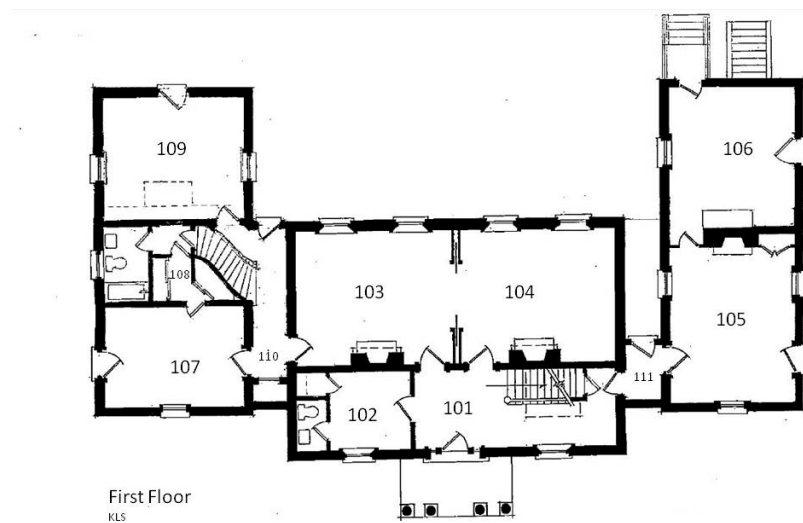
Figure 11. Current first-floor plan with numbers added for room identification (FOHR).

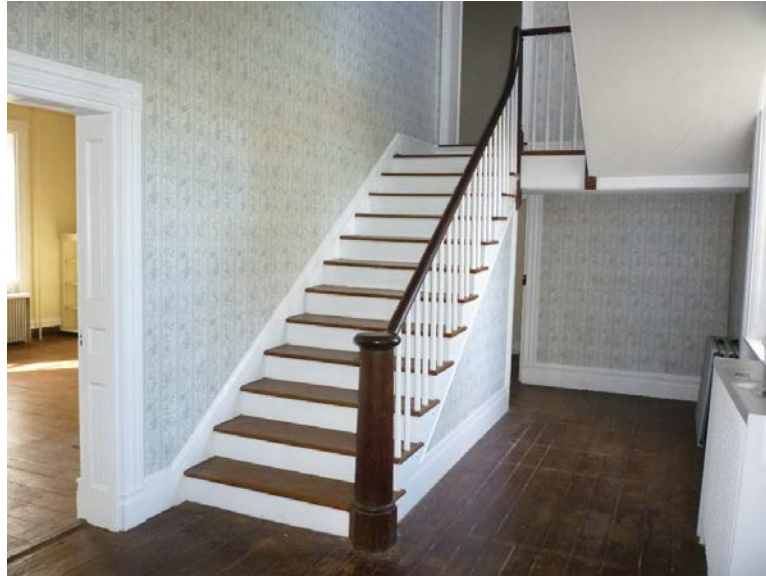
The main entry into the 1842 central block is through the front portico and the six-paneled, single-leaf, wood door, which leads into the 24' long by 10-foot wide transverse hall (Room 101). A metal radiator is located along the north wall next to the entry. The open-well, open-string staircase is situated along the rear south wall, and rises to the west. The oversized circular newel rests on an octagonal base; it measures 24" at its bottom and tapers to 21" at its round-cushioned top. The tapered circular pickets and

secondary posts support the rounded unpainted handrail. The wooden drops off the newels are circular with a nipples crown. A wave motif with a drop-applied molding decorates the end of each stair tread. The underside of the staircase is a plastered triangular field and a door beneath it leads to the single-run basement stairs.

Figure 12. First-floor stair hall, Room 101 (2016). Note the wallpaper pictured here was removed by the FOHR in 2016.

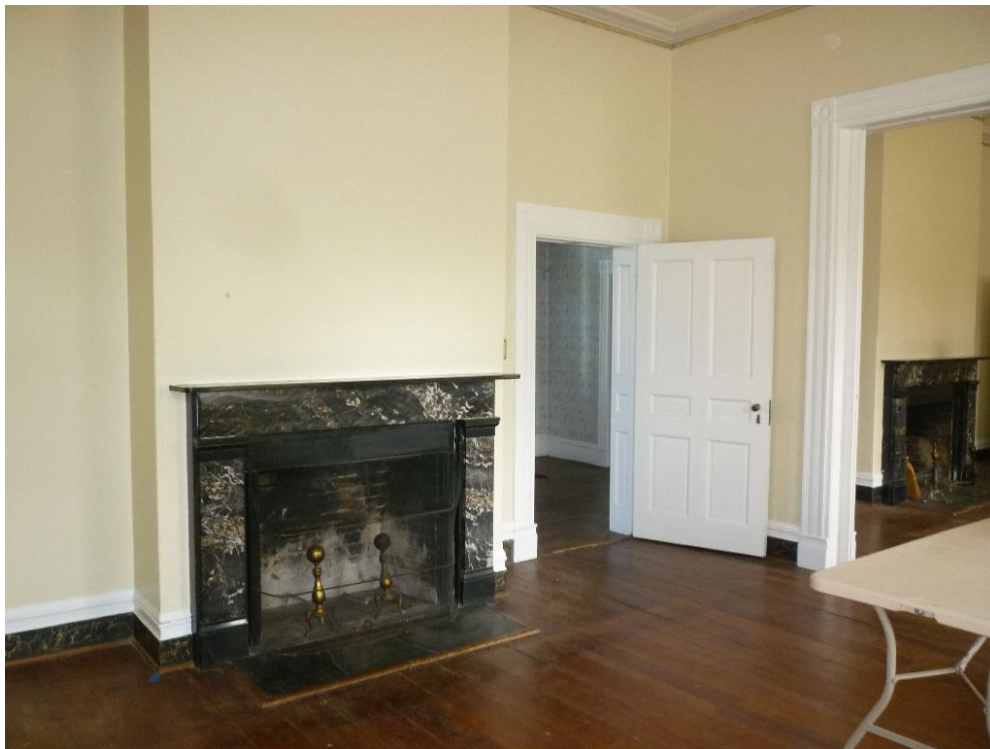
Two doors on the south wall in front of the stairs lead into the nearly matching east and west parlors (Rooms 103 and 104). These are the most formal rooms in the house and are nearly identical in finish, with two windows along the south wall, a fireplace along the north wall, and oversized complex coved cornices. Both rooms also have plastered ceiling medallions with concentric circles framing acanthus leaves and a central six-lobed flower. Full height, double-leaf, six-paneled pocket doors connect the two rooms. The Greek Revival-style mantels in the parlors appear to be of Italian marble and were probably ordered from Baltimore or New York.¹ The baseboards in both parlors have been painted a marbled pattern to match the mantels. Bookcases along the west wall of Room 104 were removed in 2016 so that wall is missing its baseboard. Radiators are located beneath one of the southern-facing windows in each room. A door along the east wall of Room 103 leads into the hyphen (Room 110).

Figure 14. The two first-floor parlors: Room 104, looking northeast into Room 103 (2016). Note the marbled painted baseboard.

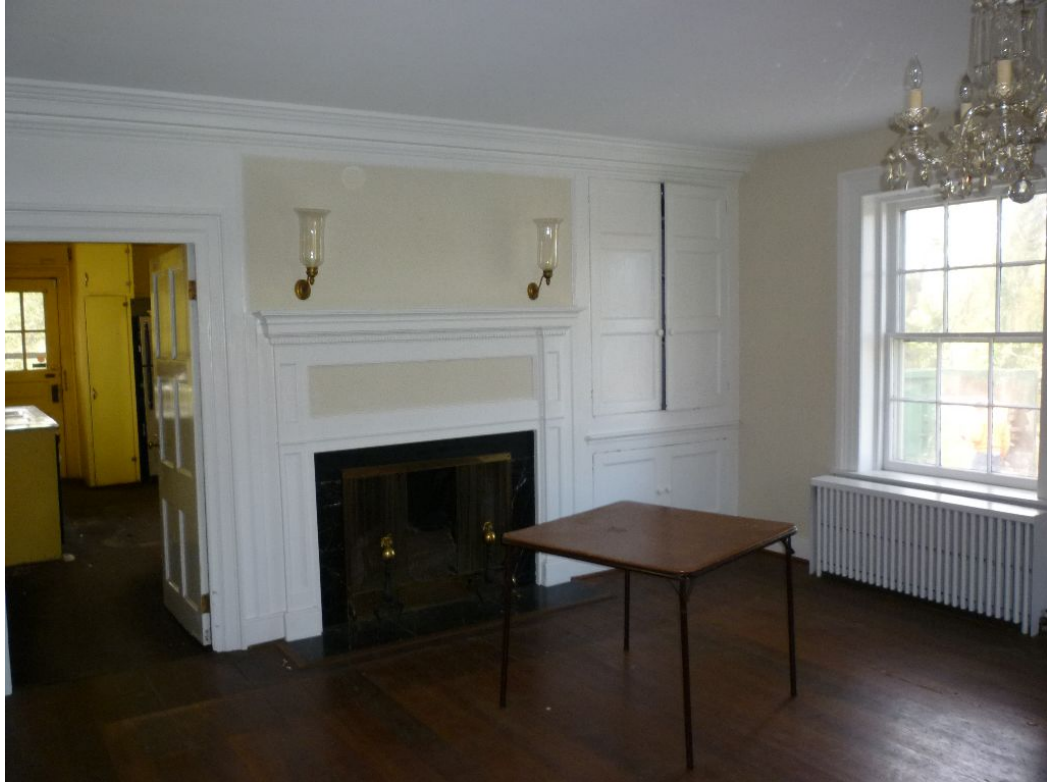
The first floor of the west wing includes two rooms: the dining room (Room 105) to the north and the former kitchen (Room 106) to the south. These spaces are the oldest in the house and are discussed in great detail in the Architectural Development section. As part of this project, the plaster along the north wall of Room 106 was removed to reveal the intact original unpainted exterior wall of Room 105, complete with mortar joints that had been penciled.

Figure 15. Room 105, referred to as the dining room, is the oldest room in the house (2016).

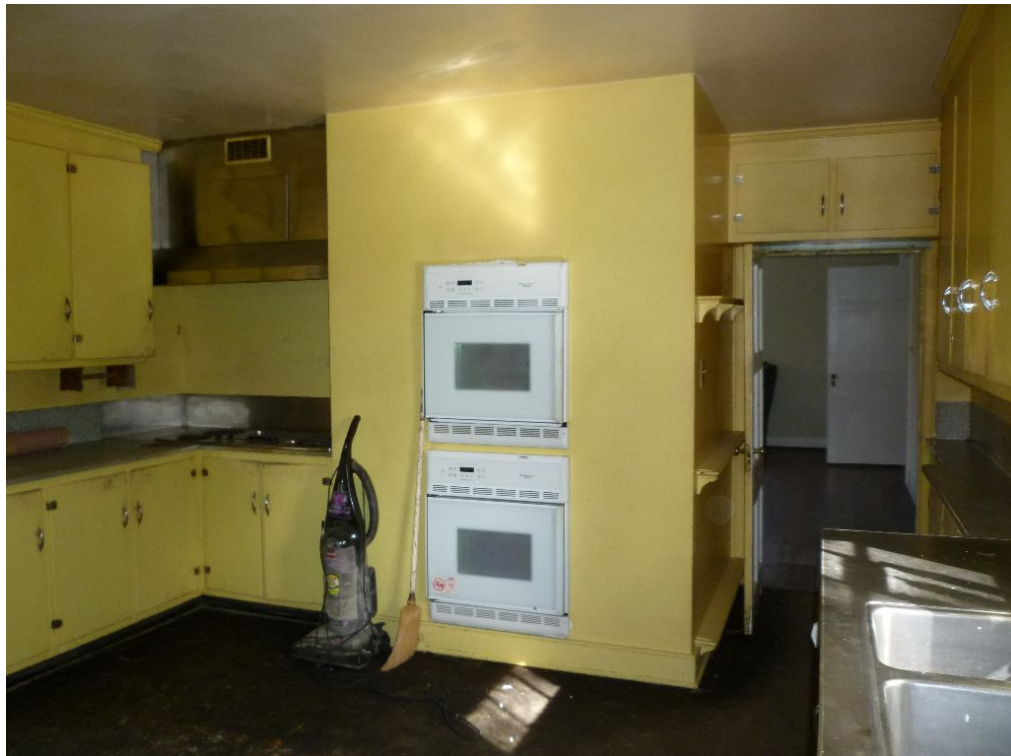
Figure 16. The former kitchen (Room 106) before demolition of the finishes. View looking north into Room 105 (2016).

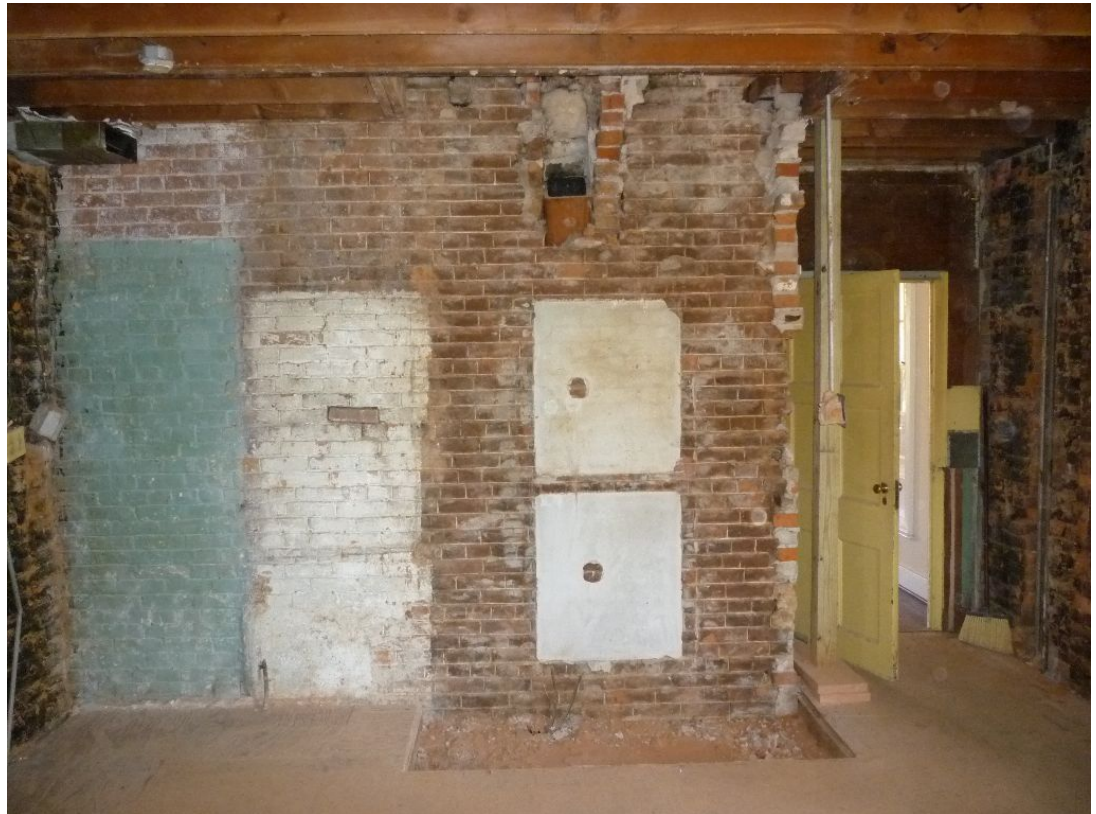
Figure 17. The former kitchen (Room 106) after demolition of the finishes. View looking north into Room 105 (2016).

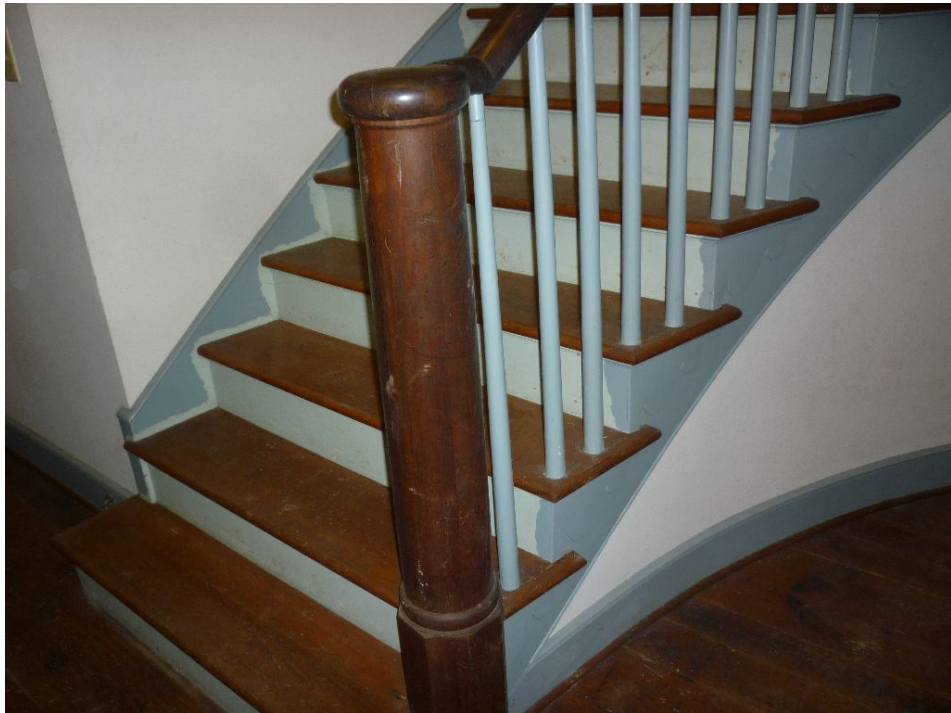
The first floor of the east wing is made up of several rooms, which reflects the significant alterations that were made to the house in 1954. The hyphen (Room 110) was extended to the south on both stories in order to accommodate a new staircase in the center of the east wing. The simple curving staircase echoes the design of the one in the main block, especially in the newel post detailing. An exterior door is located along the south end of this hyphen. The northern-most room in the east wing (Room 107) measures roughly 11'x16'. It contains a window centered on the north wall, an exterior doorway on the east wall that once led to a small stone terrace, and a door along the south wall that leads into a hall (Room 108). This central area of the first floor of the east wing (Room 108) includes a hallway, part of the stair to the second floor, a closet, and a bathroom. To the south is Room 109, which is currently being converted into a catering kitchen by the FOHR. A stair along the east wall was removed and a window was inserted along that elevation as part of the 1954 remodeling of this room, which was known as the old "winter kitchen." An exterior doorway is centered on the south wall; a window is centered on the west wall. The doorway between Rooms and 109 was modified and closets flanking it were built in 1954. Archaeological investigations carried out in 2016 revealed the stone foundation for the original partition, along with the base of a chimney attached to the foundation that had been removed before the 1954 alterations.

Figure 19. Staircase in east wing (2016).

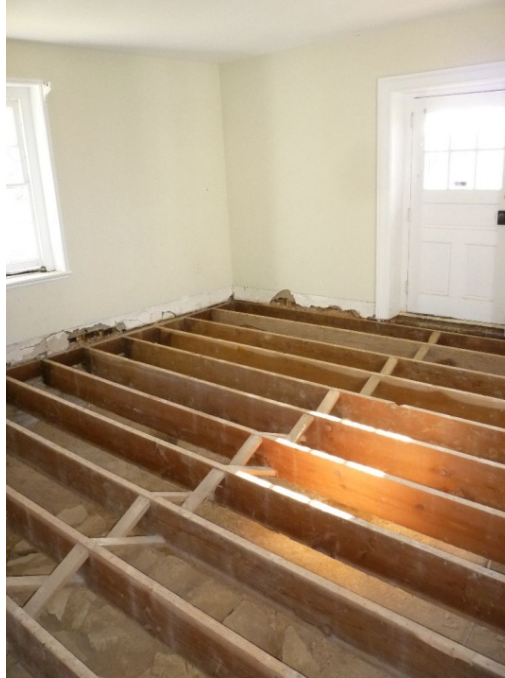
Figure 20. Room 109, with flooring removed (2016).

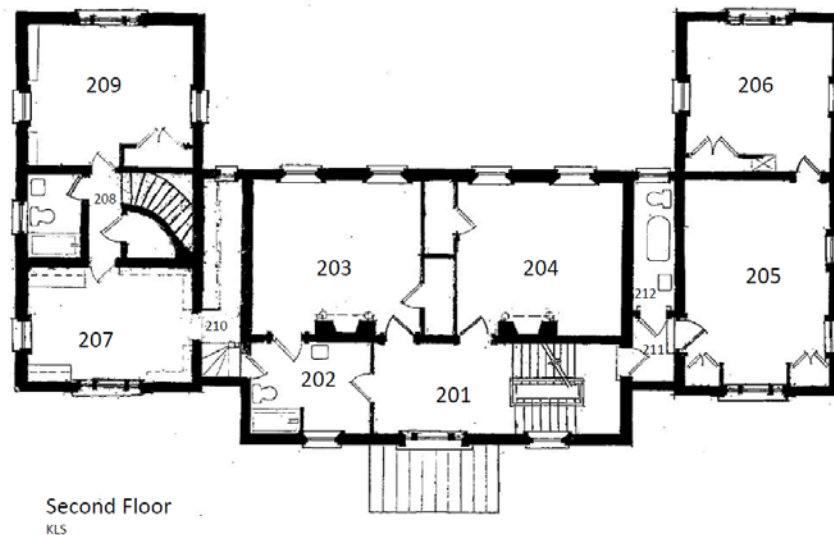
Figure 21. Current second-floor plan with room identification added (FOHR).

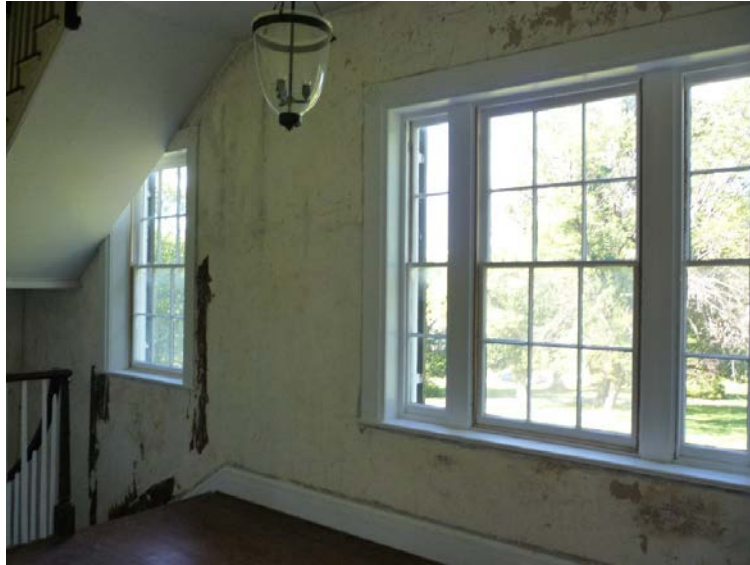
The stair rises from the first floor to a landing with a doorway into the second floor of the west hyphen (Room 211). The stair then turns and continues to the second-story transverse hall (Room 201). A single six-over-six-sash window and a larger tripartite window are located along the north wall. A bathroom (Room 202) and a doorway to the east wing occupy the east end of the stair hall.

Figure 22. Stair at second-story landing (2016).

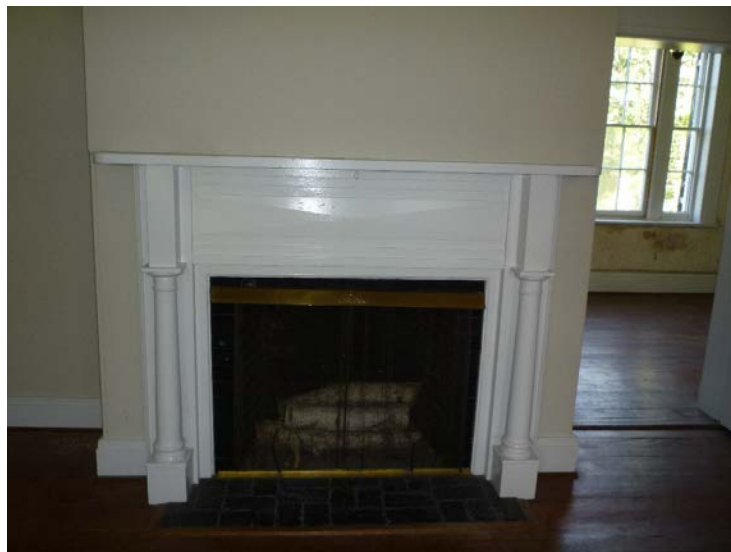
Two doors along the south wall lead into the two bedrooms (Rooms 203 and 204) that correspond to the two parlors on the first floor. Built-in closets in the central wall divide the two rooms and feature closed-in transoms above the doors. The matching wooden Greek Revival-style mantelpieces in each room are made up of Tuscan columns on plinths supporting plain end blocks with a raised-pyramidal paneled entablature. The plain mantel shelf has rounded corners and the hearth is brick.

Figure 23. Mantel in Room 204 (2016).

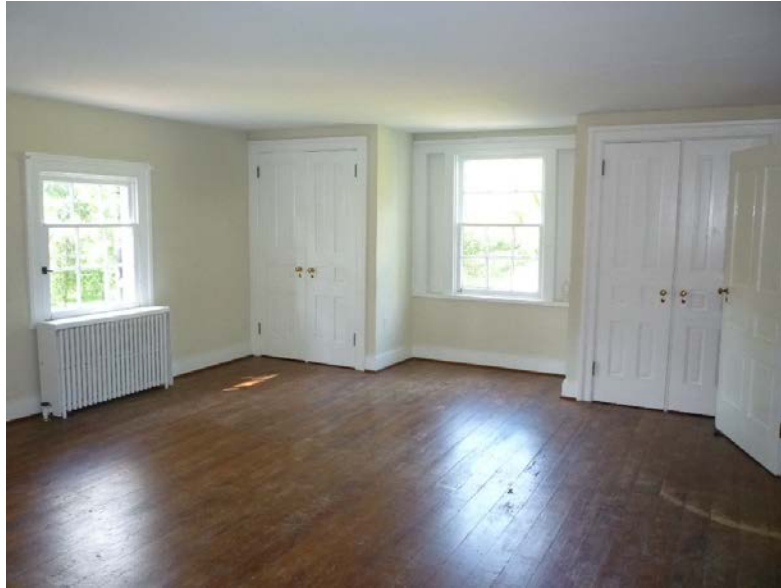
The east bathroom in the west hyphen (Room 212) was upgraded in 1954 and was probably originally installed during the early 20th century. Steps lead up from the hyphen into Room 205 in the west wing. Two closets flank the north central window of that room. A mantel once located on the south wall was removed during the 1954 renovations and appears to be one of those currently stored in the basement.

Figure 24. Room 205 looking northwest (2016).

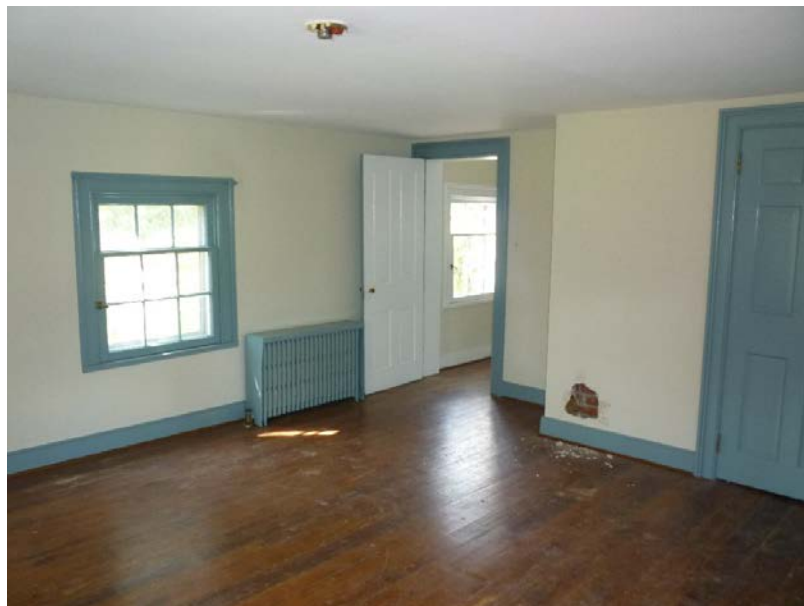
The south room of the west wing (Room 206) was remodeled in 1954 when a staircase and small hallway were removed along its west wall. The flue on the north wall next to a closet has recently been removed.

Figure 25. Room 206, looking northwest (2016). The brick flue next to the closet was removed by the FOHR in 2016.

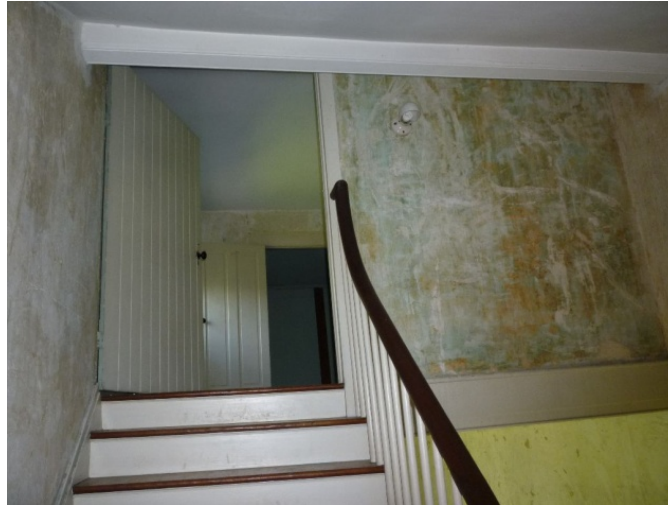
The attic of Happy Retreat is confined to the main block. The stair continues to a landing from the second floor and then turns and rises up to the attic landing through a doorway. The lunette window in the front pediment of the house takes up the north wall of the landing. A closet is located behind the two-panel door on the east end of the landing and a six-panel door on the south wall leads into a large finished room. The only light source

Figure 28. Looking up to attic landing (2016).

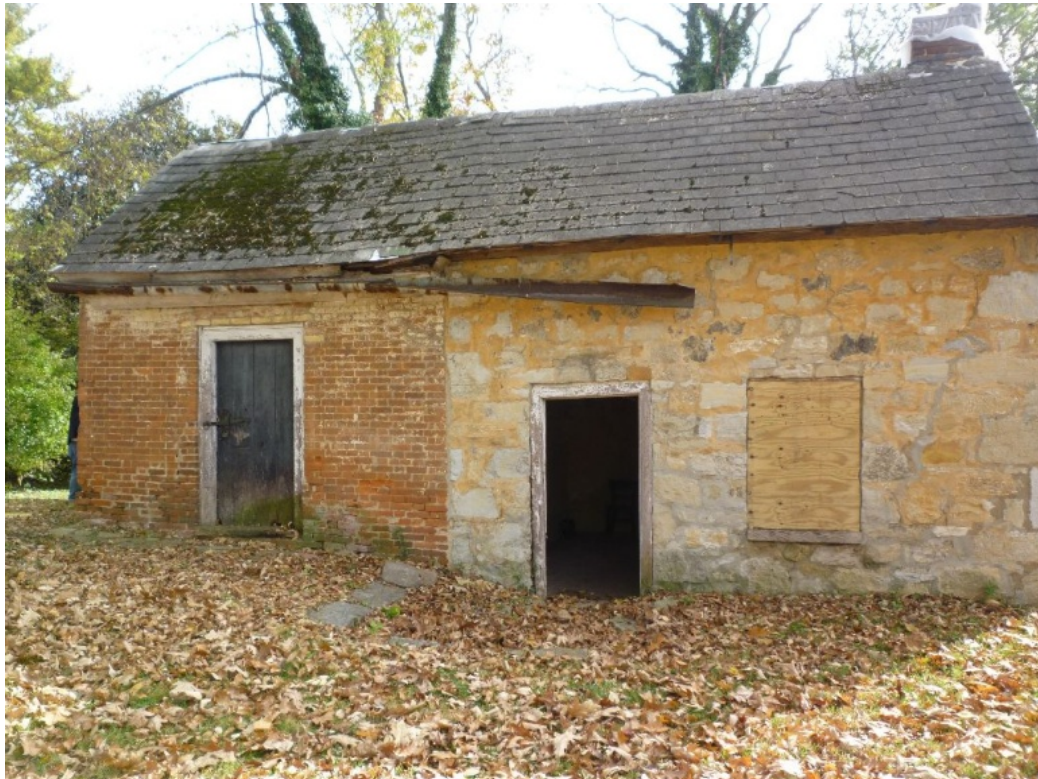
century stone kitchen wing addition. The brick privy off the back of the smokehouse was added in the 20th century, replacing an earlier frame lean-to. This interesting building is discussed in detail in the Architectural Development chapter. Structural engineer Tim Painter conducted a preliminary structural assessment of the building as part of this study, which has already been shared with the FOHR Board. Since this project began last year, the deteriorated roof of this building has been covered in tarps to prevent further water penetration and wood shoring has been installed along the rear and south wall of the kitchen.

Figure 30. West view of smokehouse/kitchen/privy (2016).

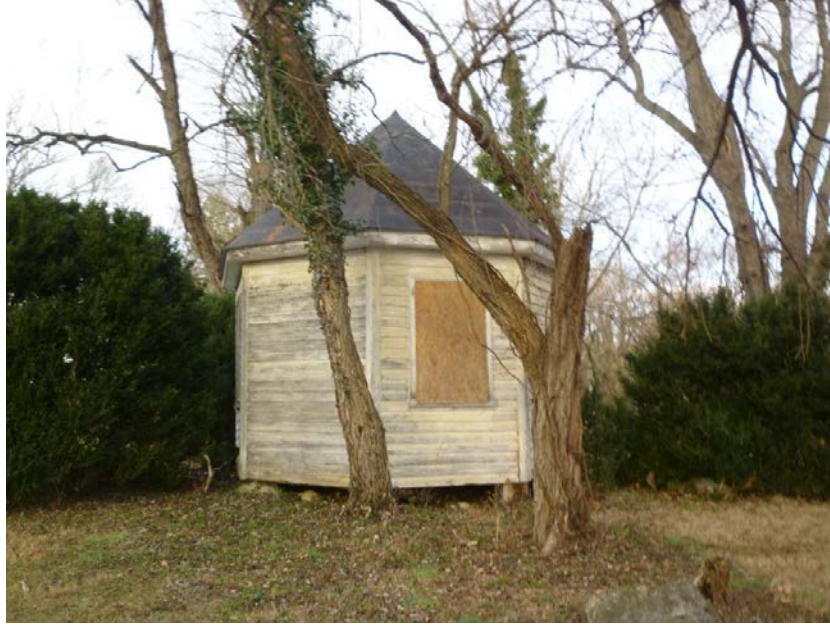
The unusual frame “schoolhouse” at Happy Retreat is located well south of the house and was moved to its current location in the 1950s. The timber-framed building is octagonal in shape and rests on a pier foundation. Six-over-six sash, double-hung wood windows are located in three of the walls and a six-paneled entry door is in the north bay. Plywood has been placed on the exterior of the window openings. The interior of the abandoned building is trimmed with chair rail and has plastered walls and a wooden floor. Some of the weatherboard siding has fallen away revealing its timber-framed construction. The octagonal roof is covered in tin shingles and features a boxed cornice and evidence of a finial. This building is worthy of additional study and careful restoration.

Figure 31. Southeast view of schoolhouse (2016).

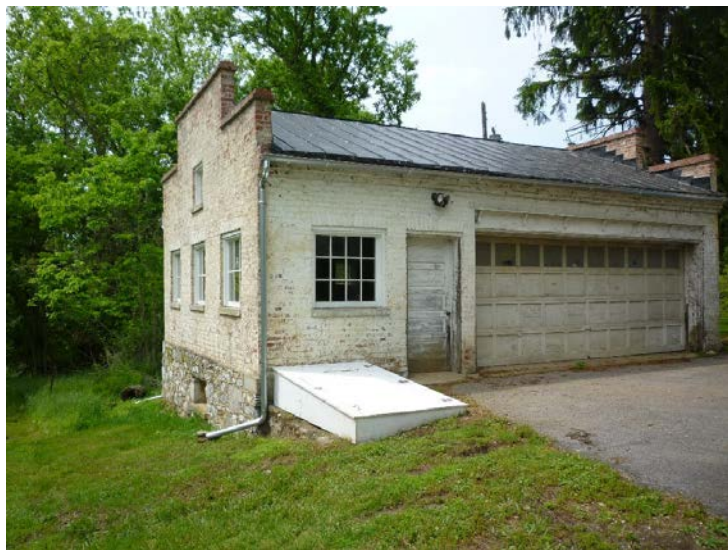
The brick garage located southwest of the main house was constructed shortly after the property was purchased by the Conklins in 1920. An effort was made to make the building fit in with the house by making it of brick construction on a stone foundation. The gabled roof with stepped brick parapet ends echoes the east and west wings. The brick are laid in a Flemish-bond pattern and the building is built into a banked site allowing for a partial basement exposed on the sides and rear. Steel windows are found on the front, sides, rear, and basement windows and have brick jack arches and concrete sills. A large garage door is located along the front elevation along with a door, window, and bulkhead basement entry. A date stone on the southeast corner reads “Conklin.” This interesting building is currently being used for equipment storage and is in generally good condition.

Figure 32. Southeast view of garage (2016).

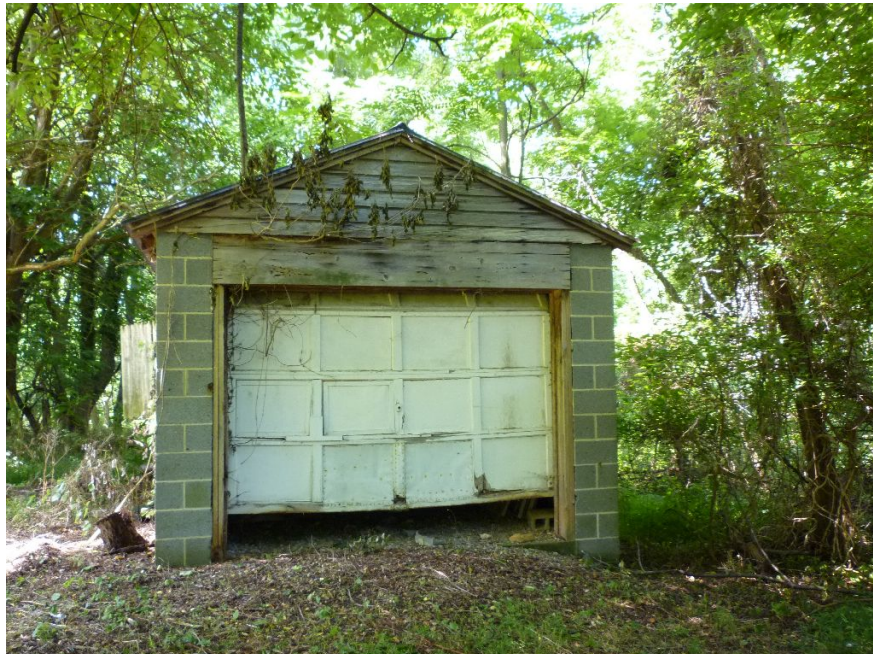
Figure 34. North view of former stable (2016).

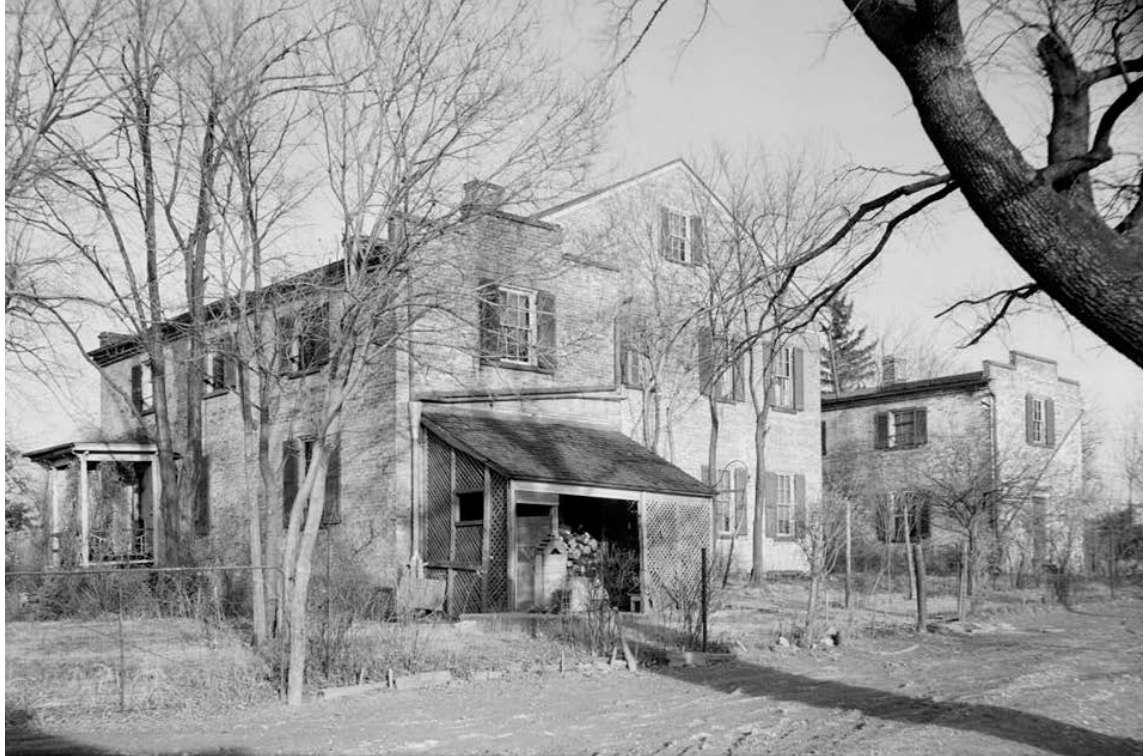
Figure 1. Happy Retreat from the southwest, west wing in the foreground; second floor, stepped gable parapets, porch and wood shed all circa 1842 and later (HABS 1937, www.loc.gov/pictures/item/wv0090.photos.172242p/resource/).

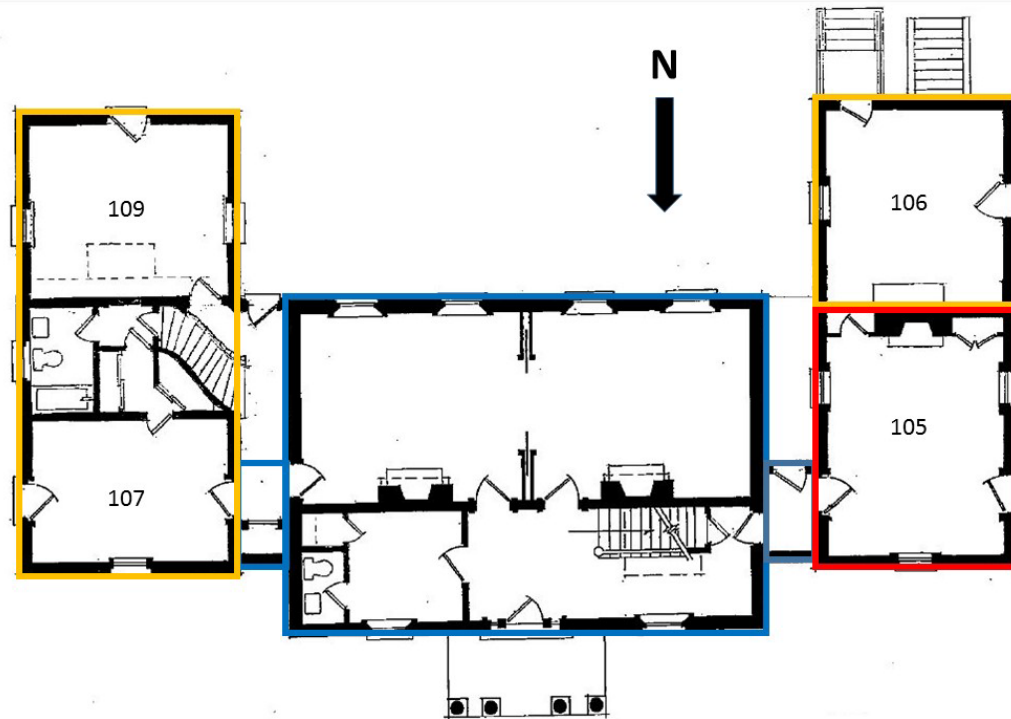
Figure 2. Chronological development of the Happy Retreat five-part plan: Period I ca. 1780 (red); Period II ca. 1785 (yellow); Period III 1842 (blue).

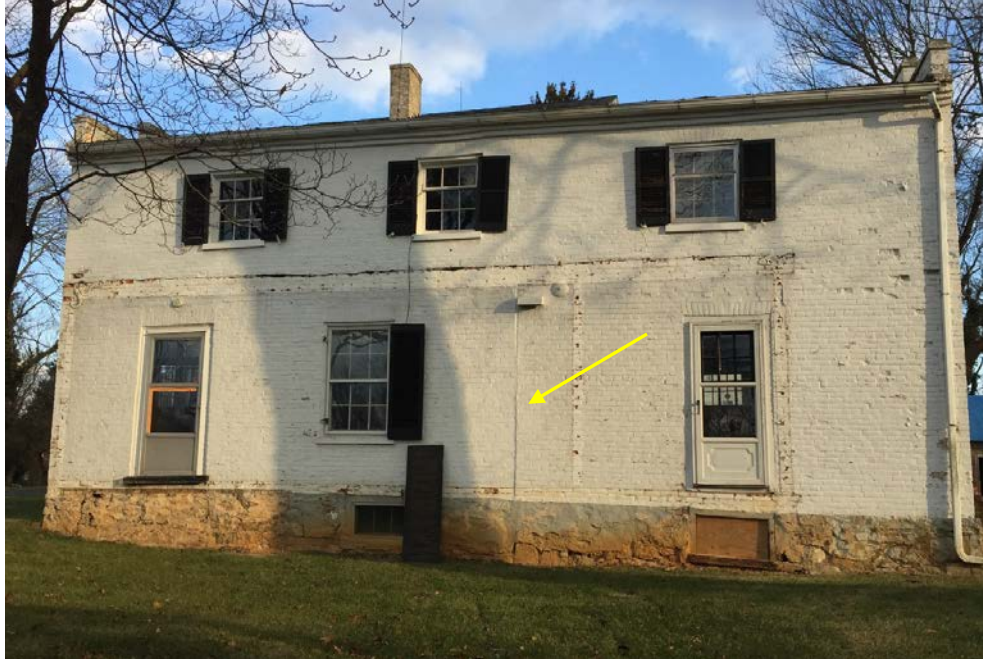
The front (north) portion of the west wing (Room 105) is the oldest extant structure on the property, and the physical evidence conforms to a construction date of circa 1780. It is currently the larger section of a two-part, two-story building (41'3" by 17'3"), with a front-gable roof and stepped gable parapets, and a roughly centered chimney located where the two units join. The brick walls rest on a stone foundation, which accommodates a full basement with a relieving arch to support the fireplace centered on the south wall of the original structure; wood shelves are built-in within the arch and in the southwest corner. A change in the pattern of brick bonding at the height of the first floor ceiling indicates that the second floor was added, very likely when the main block was completed in 1842. Vertical seams in the east and west walls mark the point of connection between the original north section and the addition. The brick walls are laid in Flemish bond on the two principal elevations (north and east); with 3:1 common bond on the west and irregular bonding on the south. The brown mortar joints were struck, then "penciled" with a thin line of white paint in an attempt to visually regularize the pattern of the masonry. The character of the masonry and of the surviving interior woodwork support an 18th century date, and the relationship with the rear wing confirms that the north portion is the earlier of the two.⁵ The three original openings in the north section -- one doorway and two windows -- featured brick jack arches and wood sills and frames; the window in the east wall of the south section is similarly constructed. The other window and three doorways were either added or altered.

Figure 3. West wing, west elevation after removal of 20th-century porch (2016): Period I one-story section on the left (north); Period II on the right; second floor added in Period III. The window and doorway in Period I section added; doorway in Period II section converted from an original window.

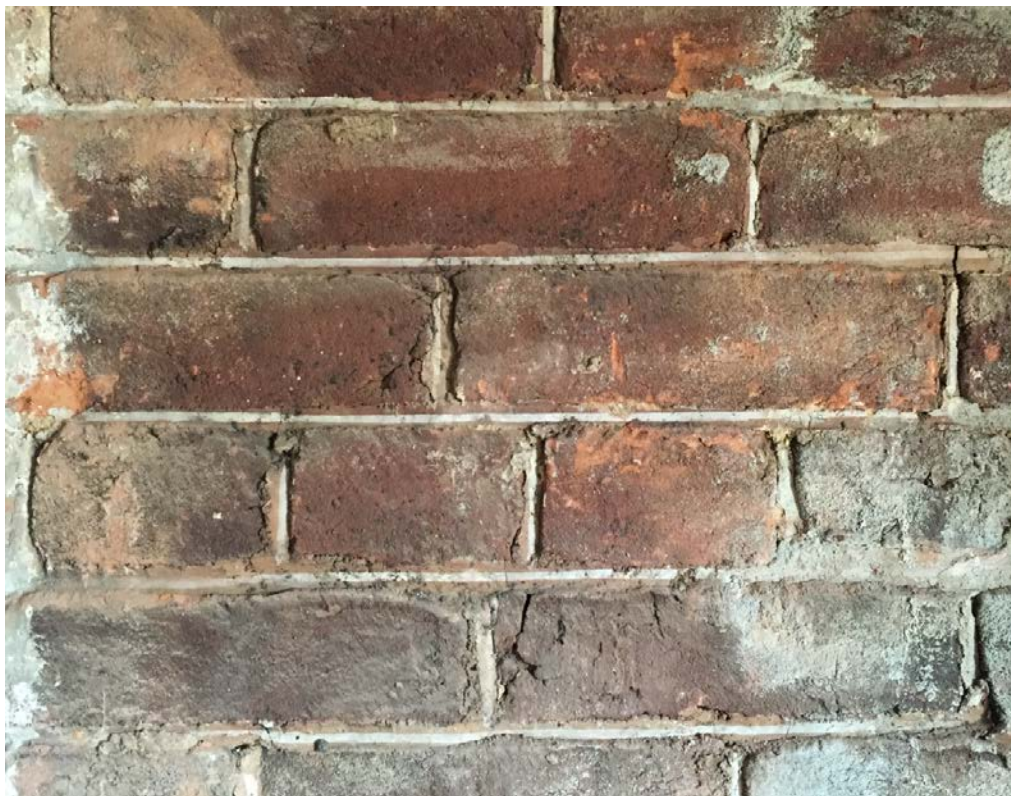
Figure 4. Ruled and penciled brick joints revealed on exterior face of Period I south wall, encapsulated within Period II Room 106 (2016).
