**PHASE 1 OF A HISTORIC STRUCTURE REPORT
HAPPY RETREAT
CHARLES TOWN, WEST VIRGINIA**

MARCH 2017

The purpose of this Phase 1 of a historic structure report was to provide a general overview of Happy Retreat’s history, trace the development of the house and refine the chronology of the building’s construction, and assess the level of historic fabric that remains from before the 1954 renovation. In addition, a conditions assessment was performed on the smokehouse/kitchen/privy outbuilding, which included a structural investigation undertaken by a consulting engineer. The rest of the 1842 house was only documented and studied on a cursory level, as the FOHR expressed the desire to focus on the first floor of the west wing, considered to be the oldest portion of the house and the one associated with the original owner, Charles Washington. A prioritized list of recommendations has been developed with reference to structural concerns, preservation issues, future research, and interpretive opportunities.

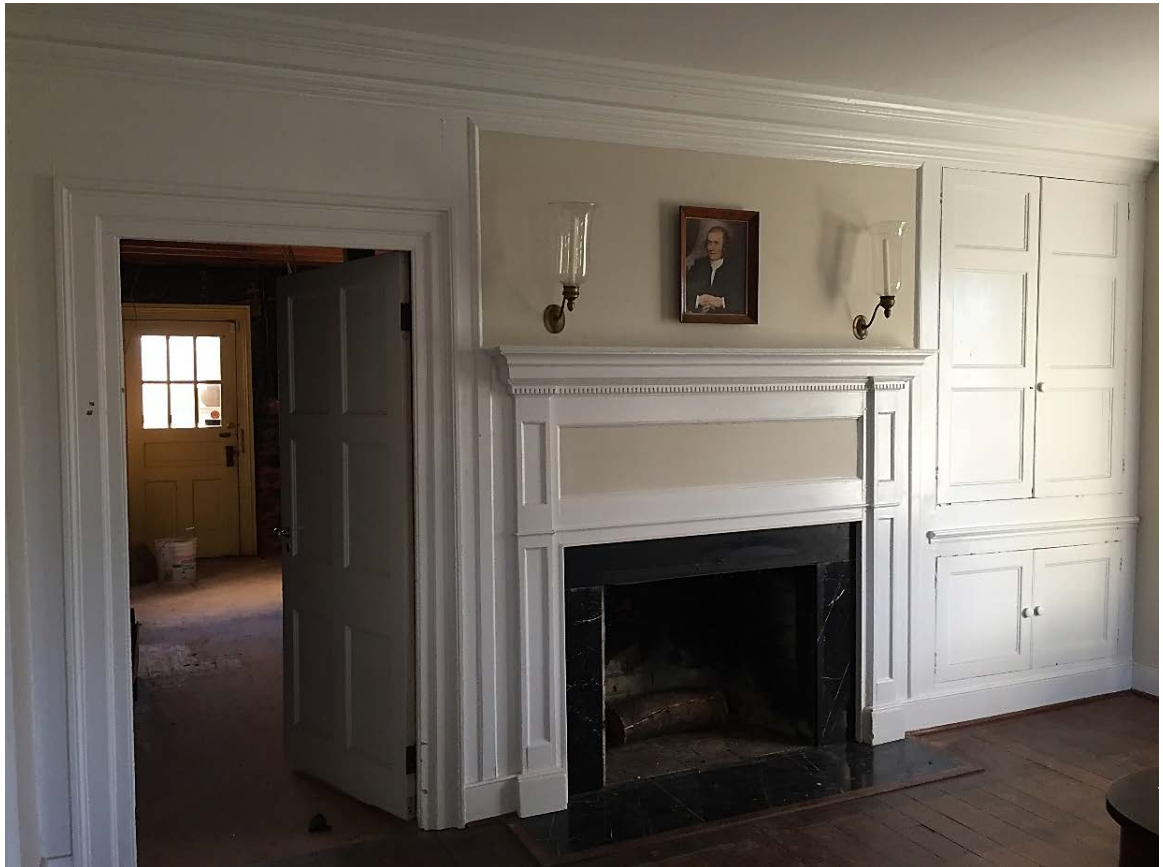
Figure 5. Room 105, south wall: doorway inserted in Period II; mantel piece a replacement; cabinet original to Period I (2016).

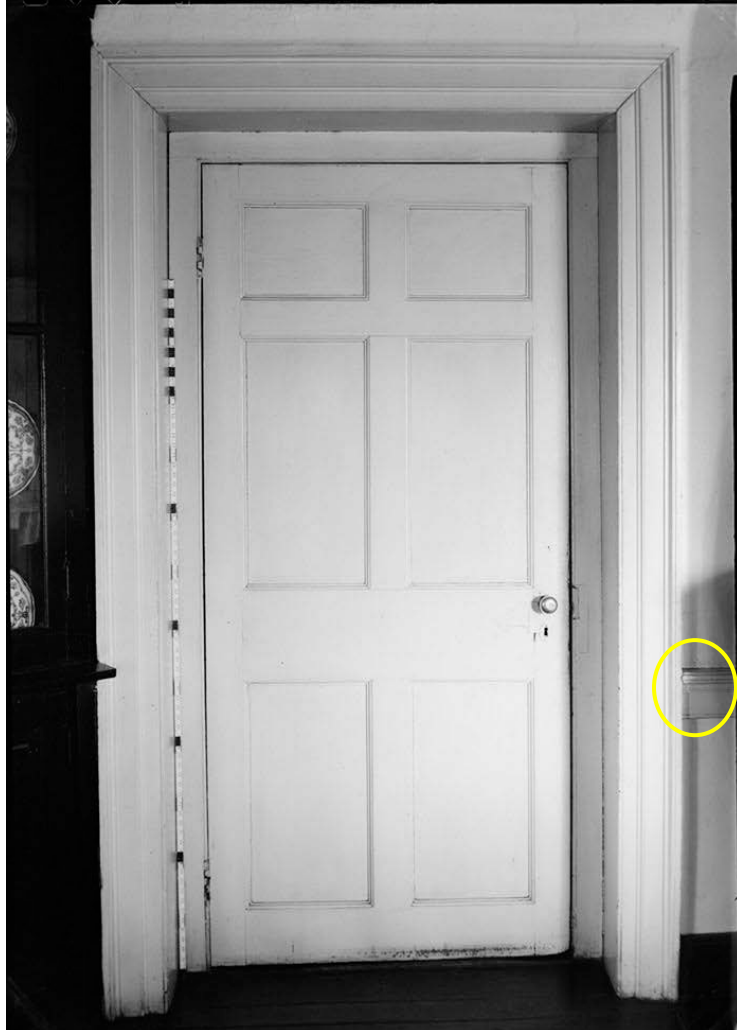
Figure 6. Room 105, Period I exterior door and door casing, showing chair rail connecting to back band (HABS 1937 www.loc.gov/pictures/item/wv0090.photos.172243p/resource/).

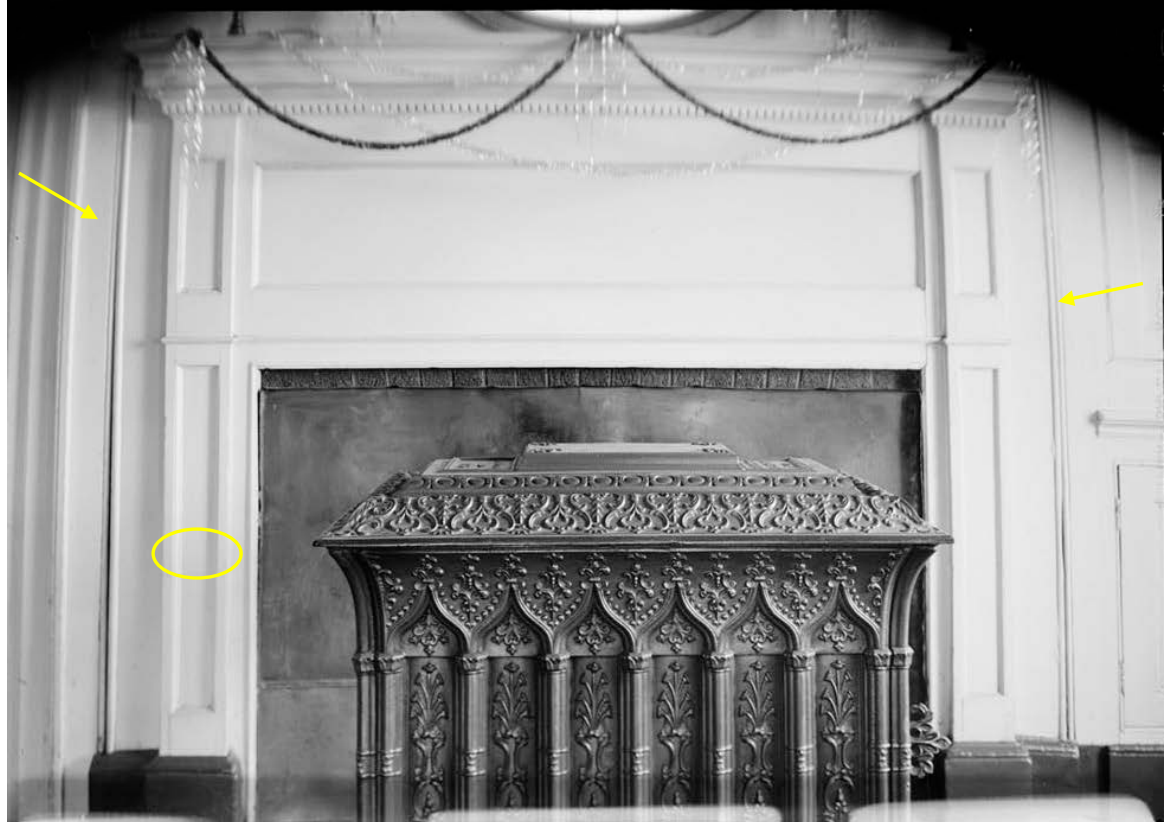
The flat-paneled mantel with a dentil band presents a puzzle, as its style fits the period of the 1780s, but physical evidence suggests that it was moved from another location and was installed at a much later date. Matching horizontal seams are visible in the flat panels on the legs, suggesting that they were cut and then spliced together, as if the mantel was altered to fit the space. The head of at least one wire nail also was found in the cornice, and photographic evidence indicates that the seams between the mantel and the surrounding woodwork on each side have been covered with a narrow strip of wood, seemingly to obscure a clumsy juncture. The results of the paint analysis are more equivocal, as the earliest layer on the mantel matches with the east door, but, given the high level of preservation found elsewhere in the room, the next 13 layers of finish are unaccountably absent. The Washington family members who in the 1920s remembered that another structure had been located nearby also contended that the mantel had been salvaged from that building and installed in Room 105.⁷

Figure 7. Fireplace and mantel in Room 105; vertical seams flanking mantel piece suggesting that the mantel was moved from another location; horizontal seam visible in the field of the panel on the lower left (HABS 1937, www.loc.gov/pictures/item/wv0090.photos.172244p/resource/).

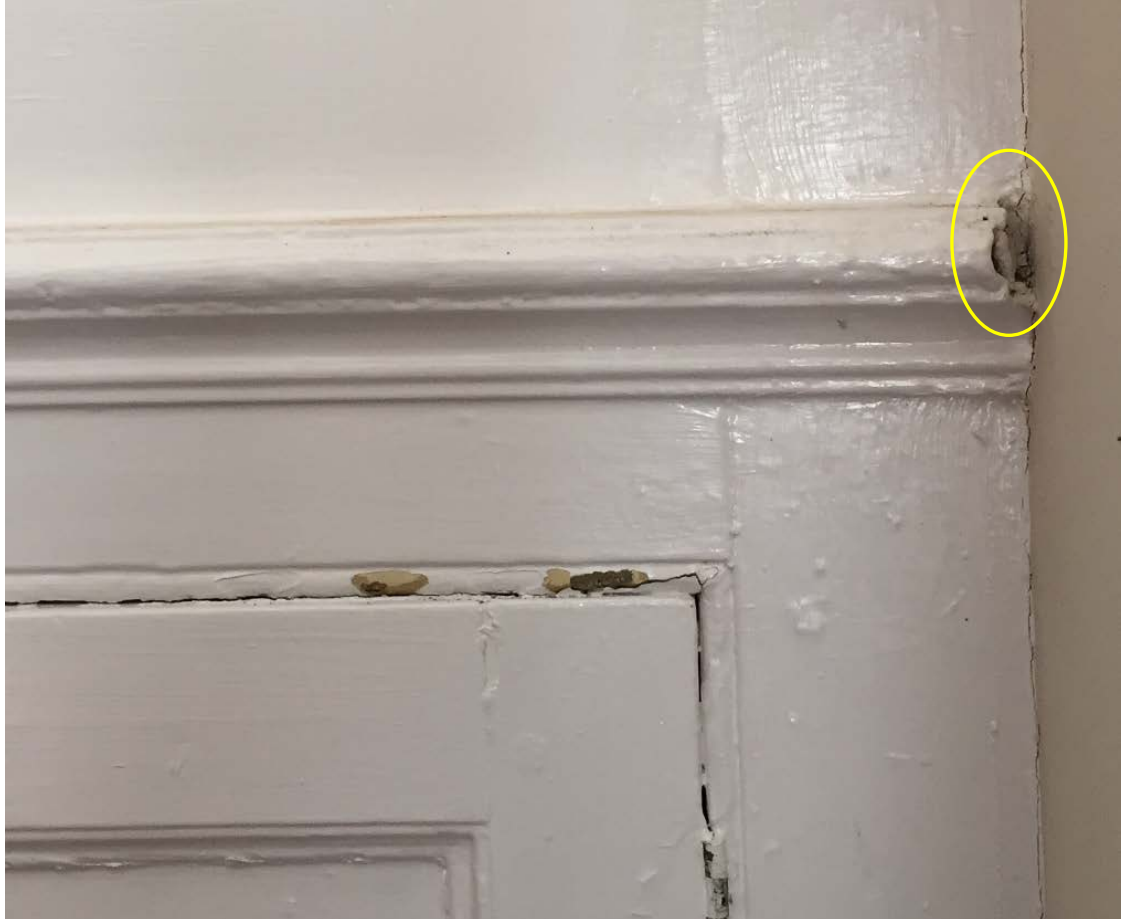
Figure 8. Detail of cabinet, showing former mitre joint between the chair rail on the cabinet and the non-extant chair rail that ran along the west wall (2016).

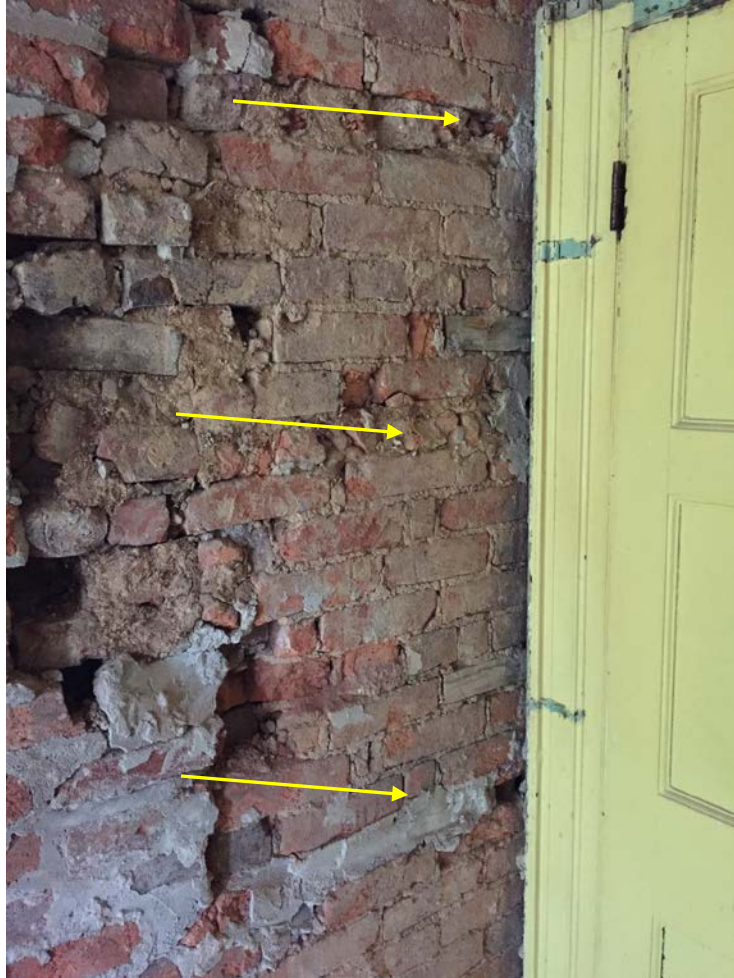
The paint evidence indicates that the decision to punch through the wall must have occurred quite soon after the original construction was completed. The new short wood wall section and the door casing were set back into the room to align with the face of the fireplace and the closet, and the character of the woodwork matches well with the rest of the room. The complete paint strata revealed on the field of the door architrave also matches with that found on the window and door trim and the chair rail, all of which begin at the verdigris-based glaze that was the second layer of paint found. Another paint sample taken from the other side of the partition revealed that the paint history there matches with the finishes on the window frame in Room 106. Therefore, it seems that all of Room 105 was painted for the first time only after the new doorway was created, which in turn indicates that the south addition to the west wing must have been erected quite soon after the north portion was completed.⁹

Figure 9. East face of Period I fireplace: on the left, scars from dismantling original south exterior wall; doorway inserted in Period II; three in-filled grooves cut into the masonry of the fireplace to support the ends of Period I shelves (2016).

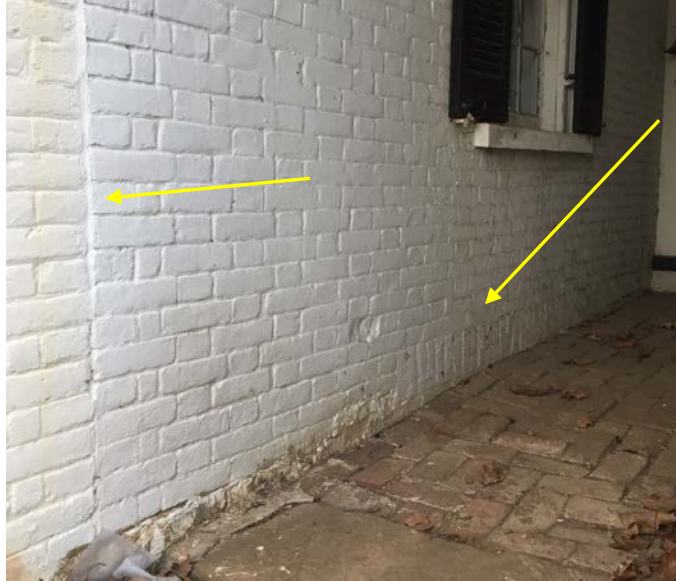
Figure 10. East wall of Period I section of west wing: vertical seam on left indicating junction of Period I and Period II construction; Flemish pattern brick bond; Period I window; soldier course of bricks below window at ground level, possibly indicating former location of bulkhead entry to the basement (2016).

The building generally follows the pattern of the hierarchy of architectural ornamentation that was commonly found in the period, with the three original openings positioned in the two walls that were laid up in Flemish bond. This east- and north-facing arrangement supports the hypothesis that the original structure was conceived as the first in a series of modules that together would comprise the completed house. Adding to the west wing and simultaneously erecting the east wing, with its façade facing the earlier building, likely followed and elaborated on that plan. The high level of finish on the interior of Room 105 indicates that it was likely conceived as a public space, and other factors raise the question of whether it was originally intended for domestic use. The prominent placement of a bulkhead stair and doorway in the structure's formal façade would have been an unusual circumstance for a dwelling, as would have the absence of windows on the rear wall.¹⁰

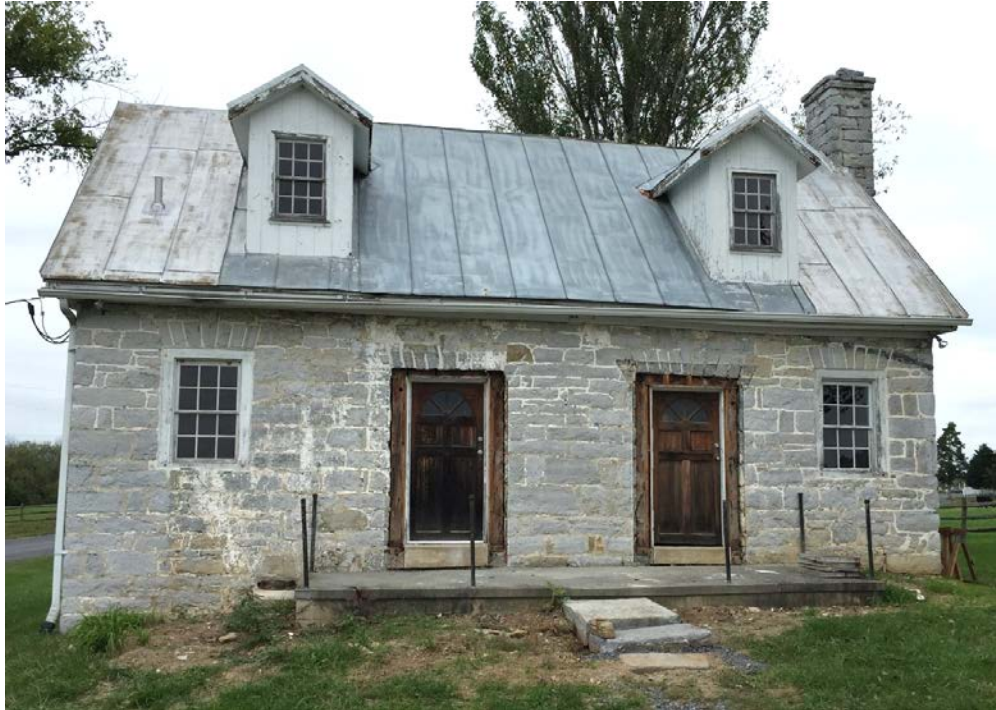
Figure 12. Two-room store at Belle Grove, Frederick County, Virginia; former bulkhead entrance to full basement located between the doorway and window on the right; dormers were a later addition (2016).

An example of a store with the standard two-room arrangement has been investigated recently at Belle Grove plantation, in Frederick County, Virginia. The one-story stone building measures 34’4” by 19’, and has two first-floor rooms, one with a fireplace and a plastered ceiling, with a full basement below. Each of the rooms has an exterior doorway and originally there was no interior connection. Access to the basement was via an exterior bulkhead stairway asymmetrically positioned in the façade. The results of dendrochronological investigations indicate that the structure was erected in the late 18th

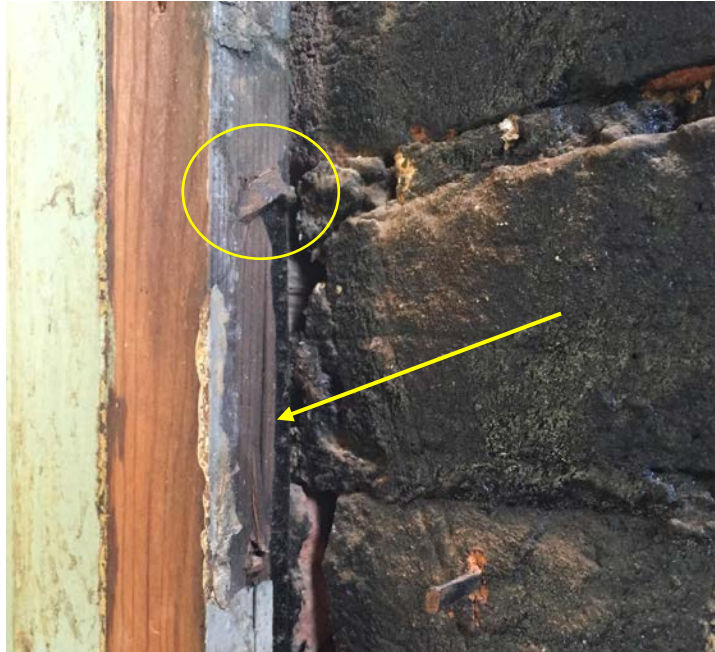
Figure 13. Paint ghost indicating square profile of chair rail found in Room 106; wrought L-head nail used to attach the chair rail, bent over and embedded in the side of the architrave (2016).

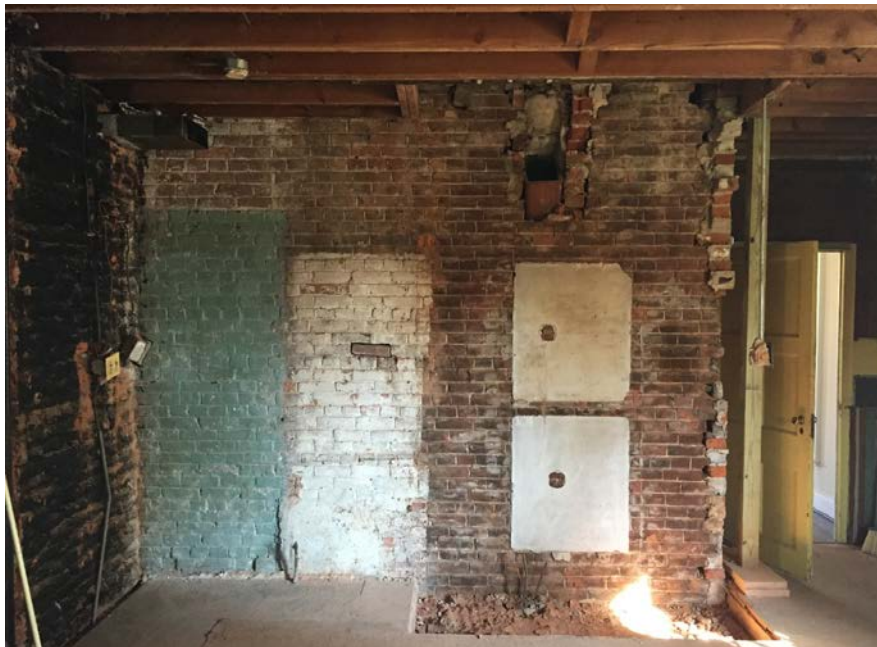
Figure 14. The north wall of Room 106, formerly the south exterior wall of the Period I Room 105; after removing 20th-century metal lathe and plaster, and the brick base that had been installed to support the chimney when it was shifted slightly to the south when the room was converted into a kitchen in 1954 (2016).

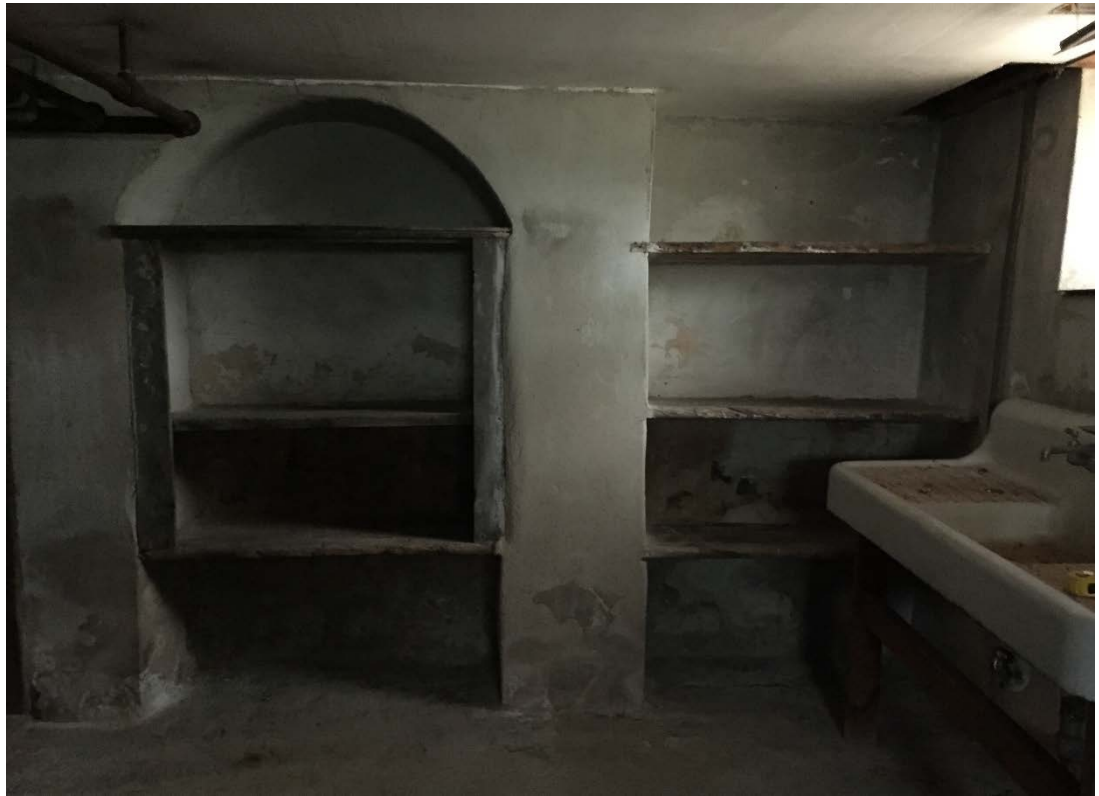
Figure 15. Built-in shelves within the relieving arch for the fireplace and in the niche between the arch and the southwest corner of the Period I basement (2016).

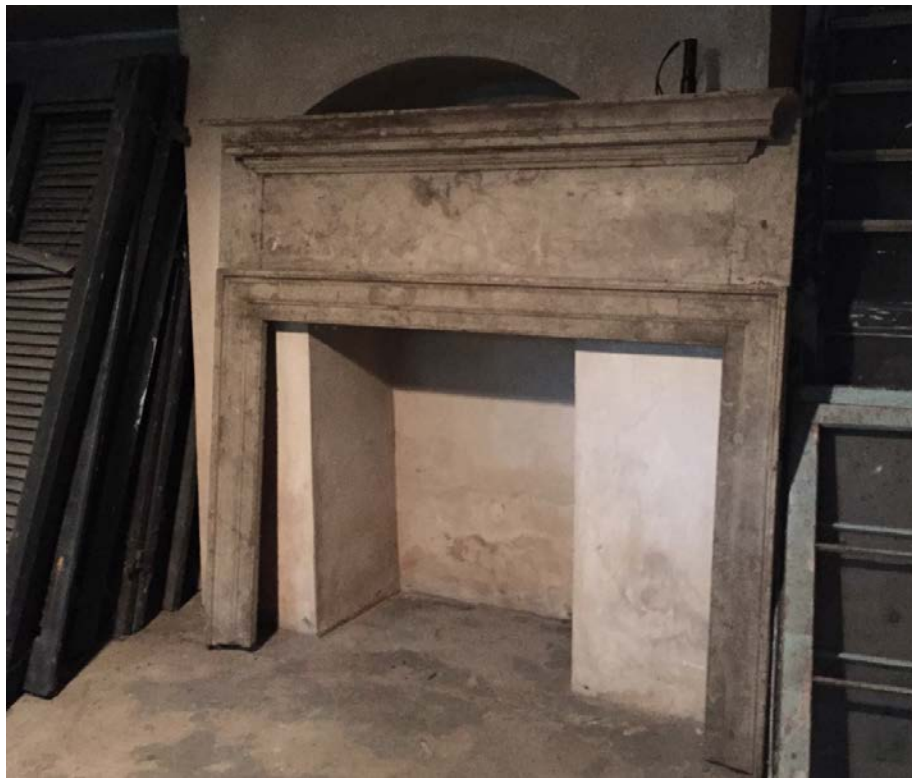
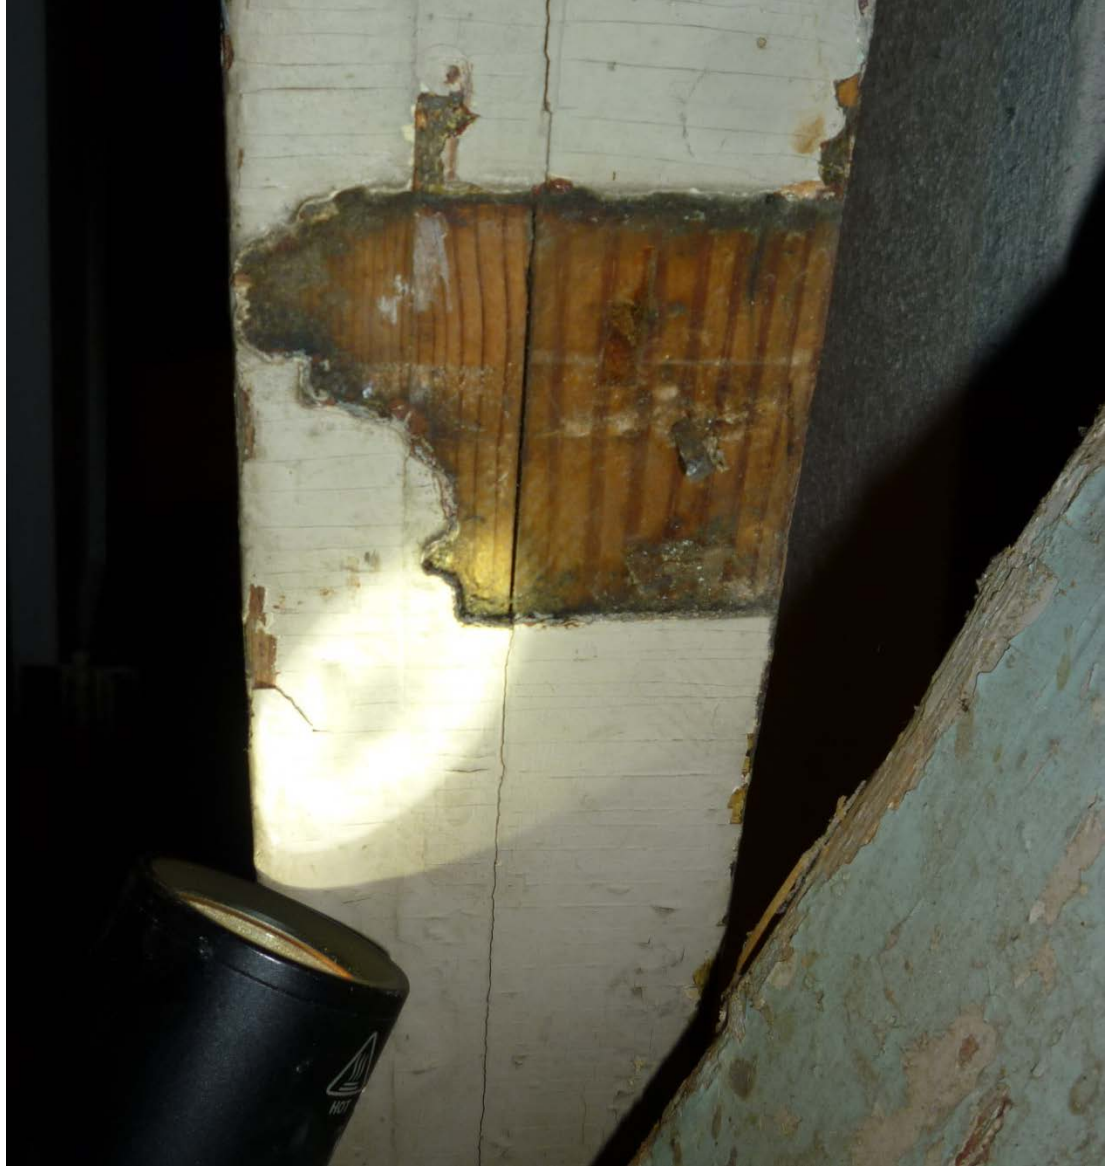
A detached wood mantel was found in the basement of the house, which exhibits a paint ghost on the side that matches the profile of the chair rail in Room 105. The overall character of the mantel is in keeping with an 18th century date, so its paint history was investigated to compare with the findings elsewhere, under the hypothesis that the mantel had been removed from Room 105. The intact sequence of eight paint layers did not match with the woodwork in that room, however, instead corresponding remarkably well with the early paint sequence in Room 106. This finding is puzzling, as the physical evidence in Room 106 conclusively indicates that a fireplace had never been located in that space, and the ghost of the chair rail found on the detached mantel does not match with the ghost of the rectangular chair rail revealed on the intact window casing. While it presents what seems to be a highly unlikely scenario, the most plausible explanation for the similarities in the paint may be that the mantel had been used in another room in Happy Retreat, presumably the east wing, which had also performed a relatively utilitarian function and was painted similarly.²⁰

Figure 16. Detached mantel stored in the basement of Happy Retreat (2016).

Figure 17. Paint ghost on detached mantel, which matches the profile of the chair rail found in Room 105 (2016).

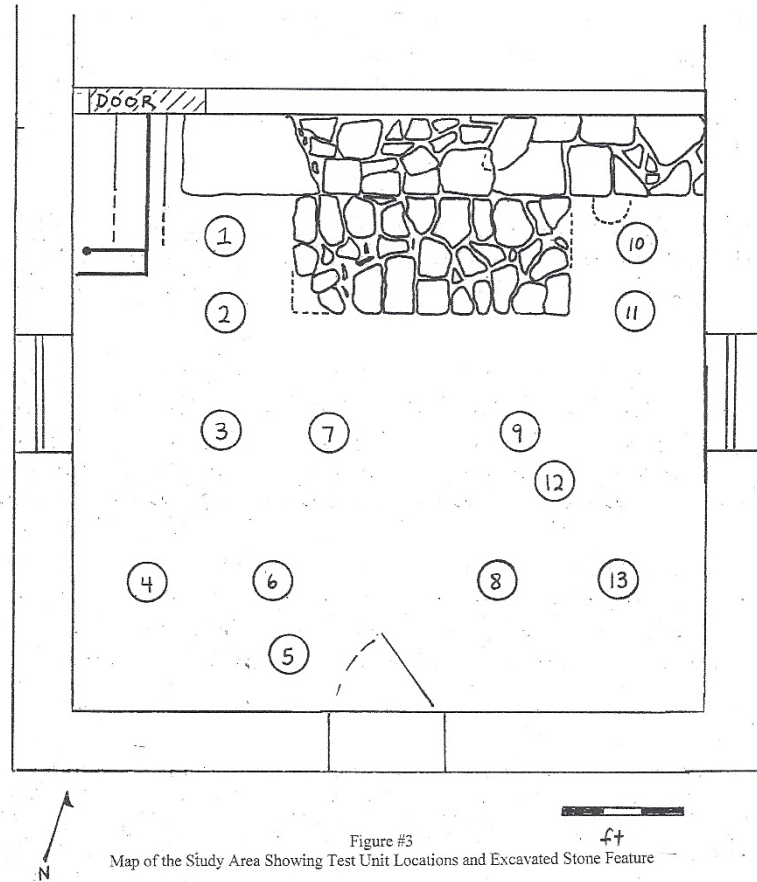
Figure 18. Plan of the ground surface below Room 109, indicating the stone base of the partition and the fireplace (from Hulse 2016).

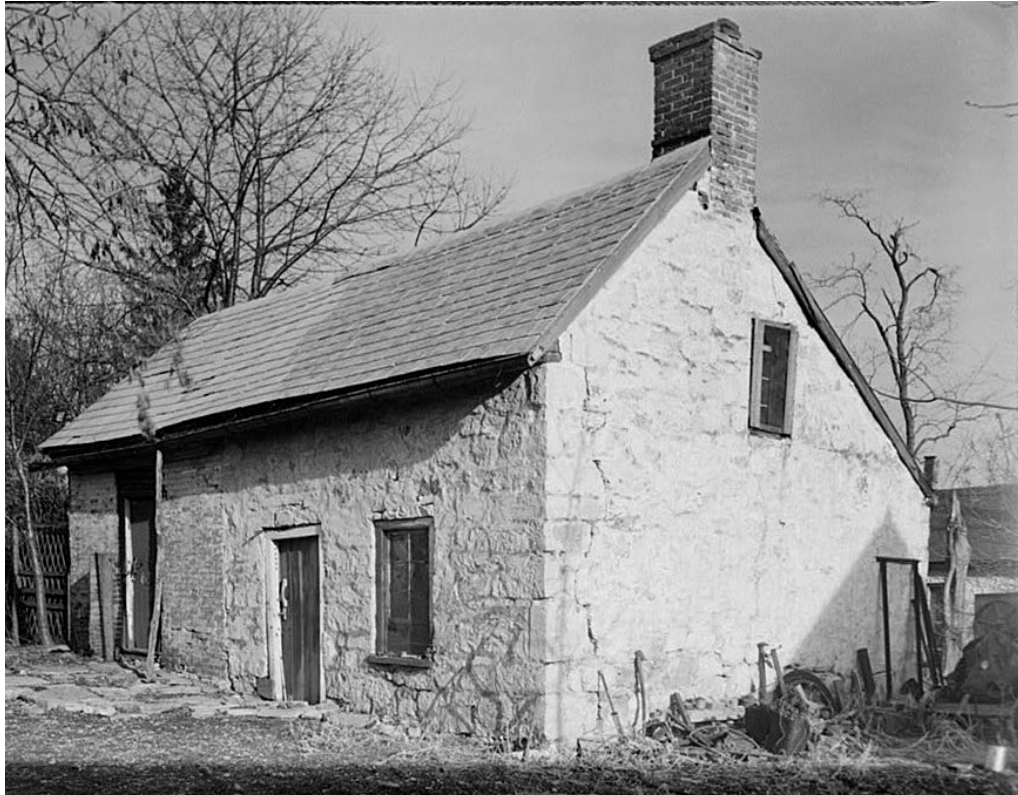
Figure 19. View of the brick smokehouse (left) and the stone kitchen; the second stone structure, with the centered chimney stack, is visible in the background (HABS 1937, <http://www.loc.gov/pictures/item/wv0090.photos.172246p/resource/>).

The stone building attached to the smoke house functioned as a kitchen on the first floor, with an unheated garret above that probably served as quarters for slaves. The substantial fireplace (5'3" wide) centered on the south end wall is flanked on one side by an enclosed stairway leading to the garret, and by a dome-shaped brick bake oven tucked into the niche between the fireplace and the southwest corner of the room.²² The nails used to fasten the collars to the rafters and the plaster lath to the collars in the garret are machine headed, indicating a date after circa 1820. Archaeological excavations conducted in the 1970s near the front door of the kitchen recovered a variety of domestic materials, all dating to the 1830s and later.²³ Construction of the stone building likely relates to removing the kitchen function from the east wing. This may have occurred as late as when the house was dramatically enlarged by erecting the main block and raising the wings to two stories in 1842. But given the choice to build the kitchen in stone, along with the presence of a second stone service building that had been located nearby, these structures may represent an intermediate step between upgrading amenities in the wing and completing the five-part brick dwelling.

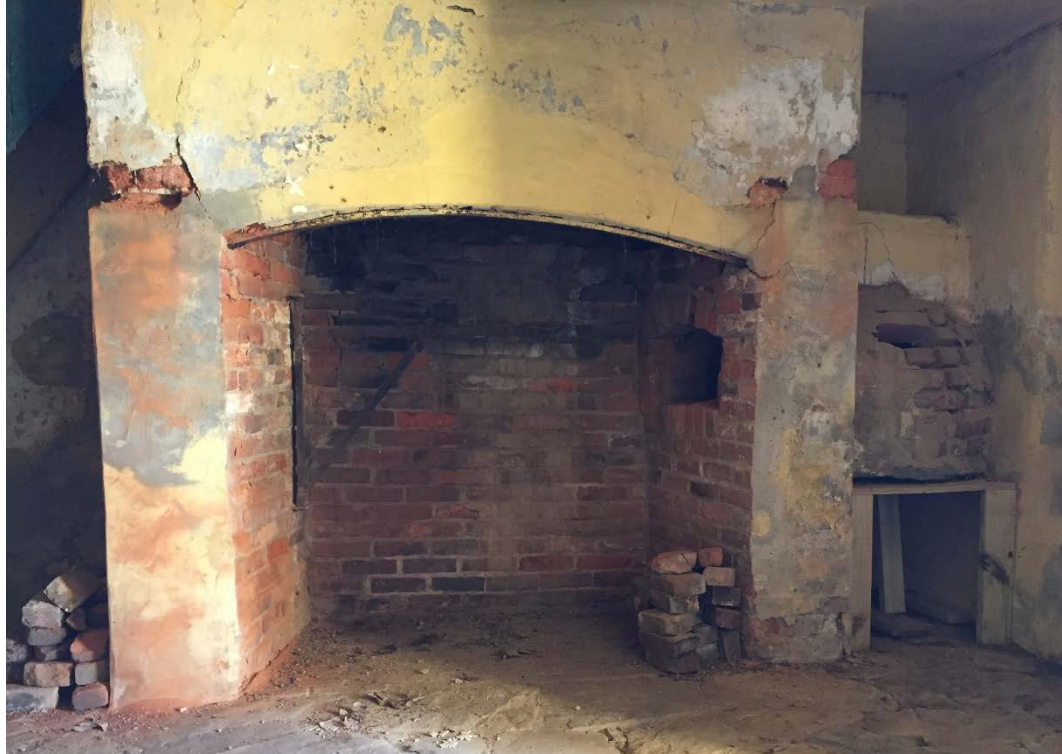
Figure 20. Fireplace and brick bake oven in kitchen (2016).

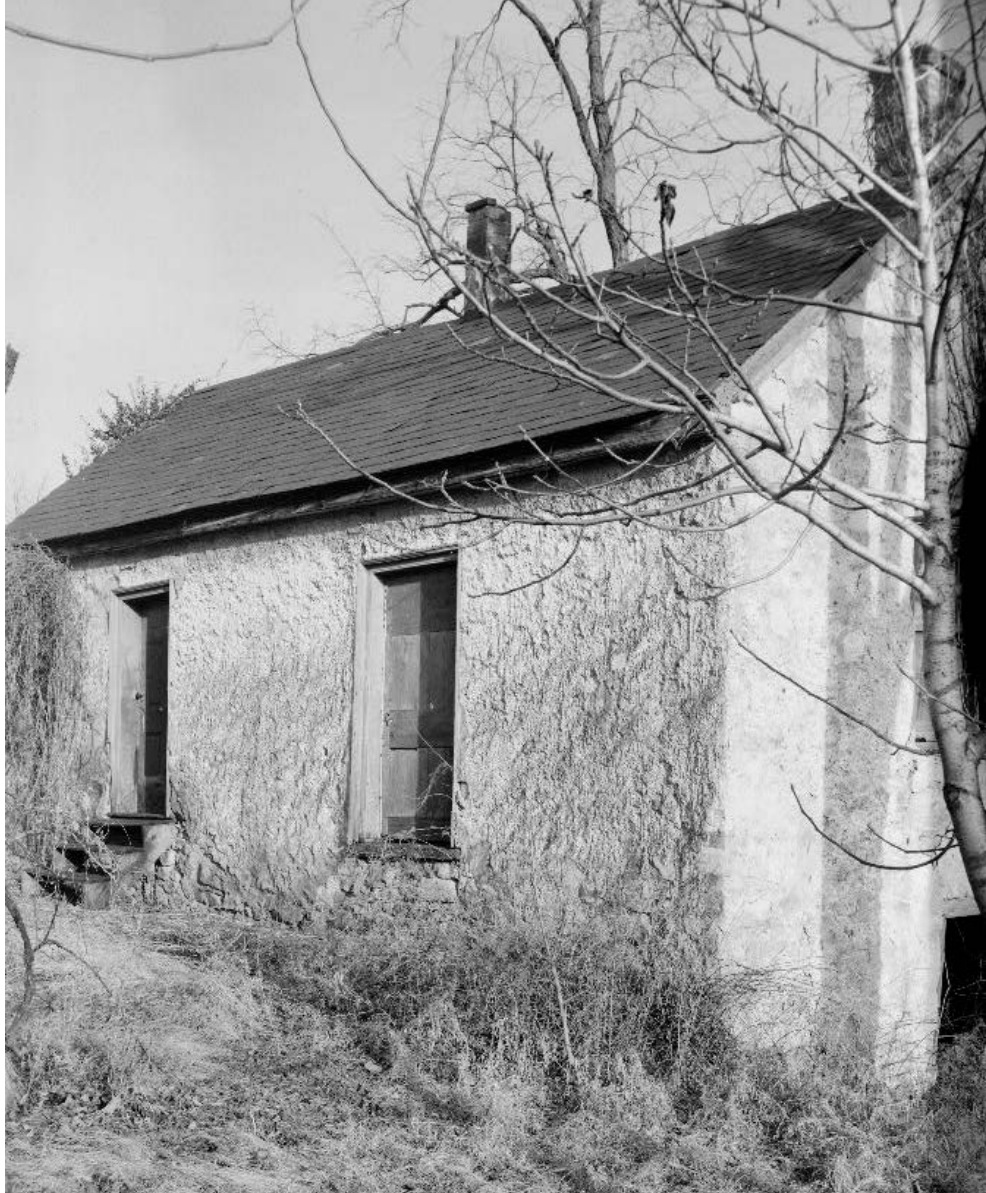
Figure 21. The second stone structure, no longer extant, which was located east of the kitchen (HABS 1937, <http://www.loc.gov/pictures/item/wv0090.photos.172247p/resource/>).

The second stone building is known to have been located just to the east of the kitchen, which survived at least until the 1940s, when the east elevation was photographed. It was a two-bay, rectangular structure, covered with a steeply-pitched side-gable roof. It had an interior brick end chimney, along with a second, narrower brick chimney roughly centered on the roof. The walls are covered with stucco in this image, and in another photograph dating to 1937. The surfaces of the stone walls are visible at several points where the stucco had failed, however, revealing them to be squared stones of varying size laid in irregular courses. The character of the stonework is similar to the kitchen building, and thus at least suggests a similar date of construction. According to one account, the building was used as “quarters for help,” and its apparent duplex arrangement was a common plan for slave quarters throughout the region.²⁴ The small center chimney likely served a wood stove, however, which almost certainly was a later feature, and the lack of an original heat source suggests that at least one of the rooms was used for storage or another non-domestic purpose.
